A Minoan Experimental House – Paying Tribute to Middle Bronze Age Cretan Vernacular Architecture

EXARC Journal Issue 2016/4 | **Publication Date:** 2016-12-01

Author(s): Sabine Beckmann ¹

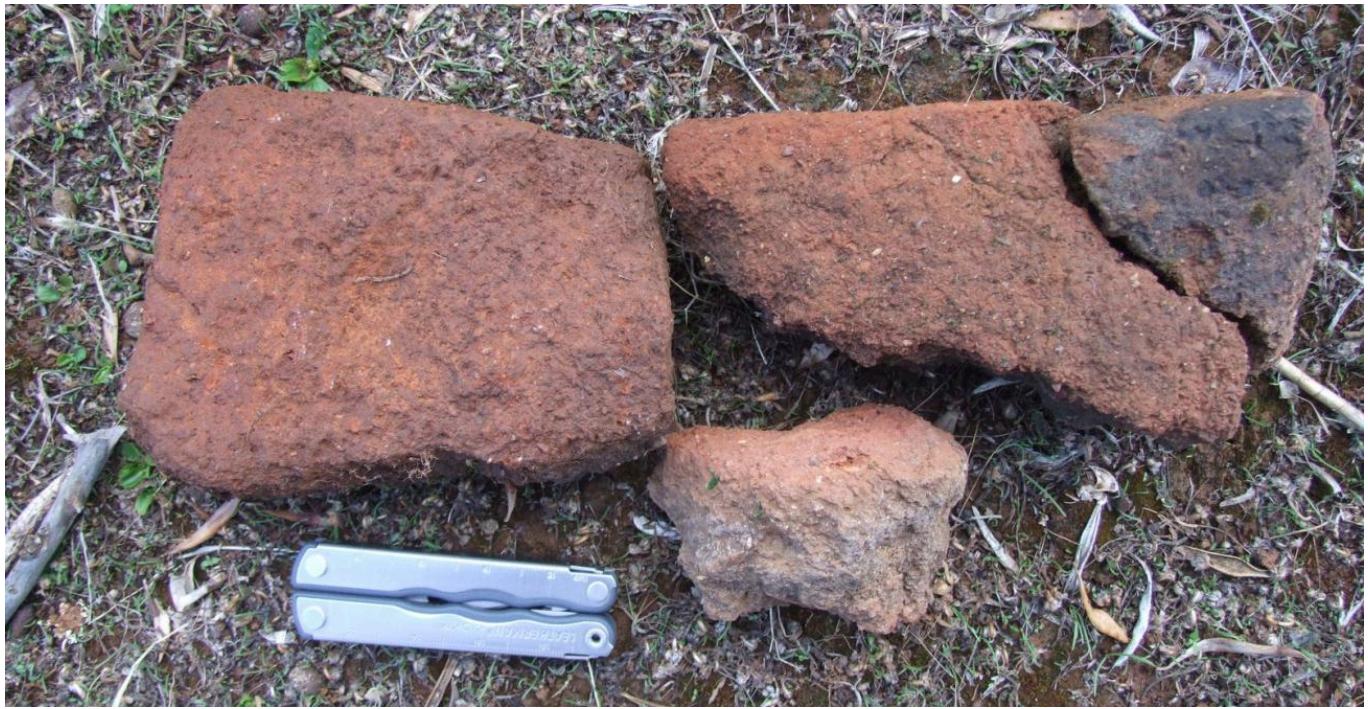
FIG 1. ACCIDENTALLY FIRED FRAGMENTS OF MUDBRICK AT A MIDDLE MINOAN SITE – NOTE THE DIFFERENCES IN COLOUR

Minoan (albeit accidentally fired) mudbricks could be seen (See Fig(See Figure 1). Consequently, I suggested that upper structures must have consisted of unfired mudbrick. This study was based exclusively on surface findings, therefore no analyses of any raw materials detected exist.

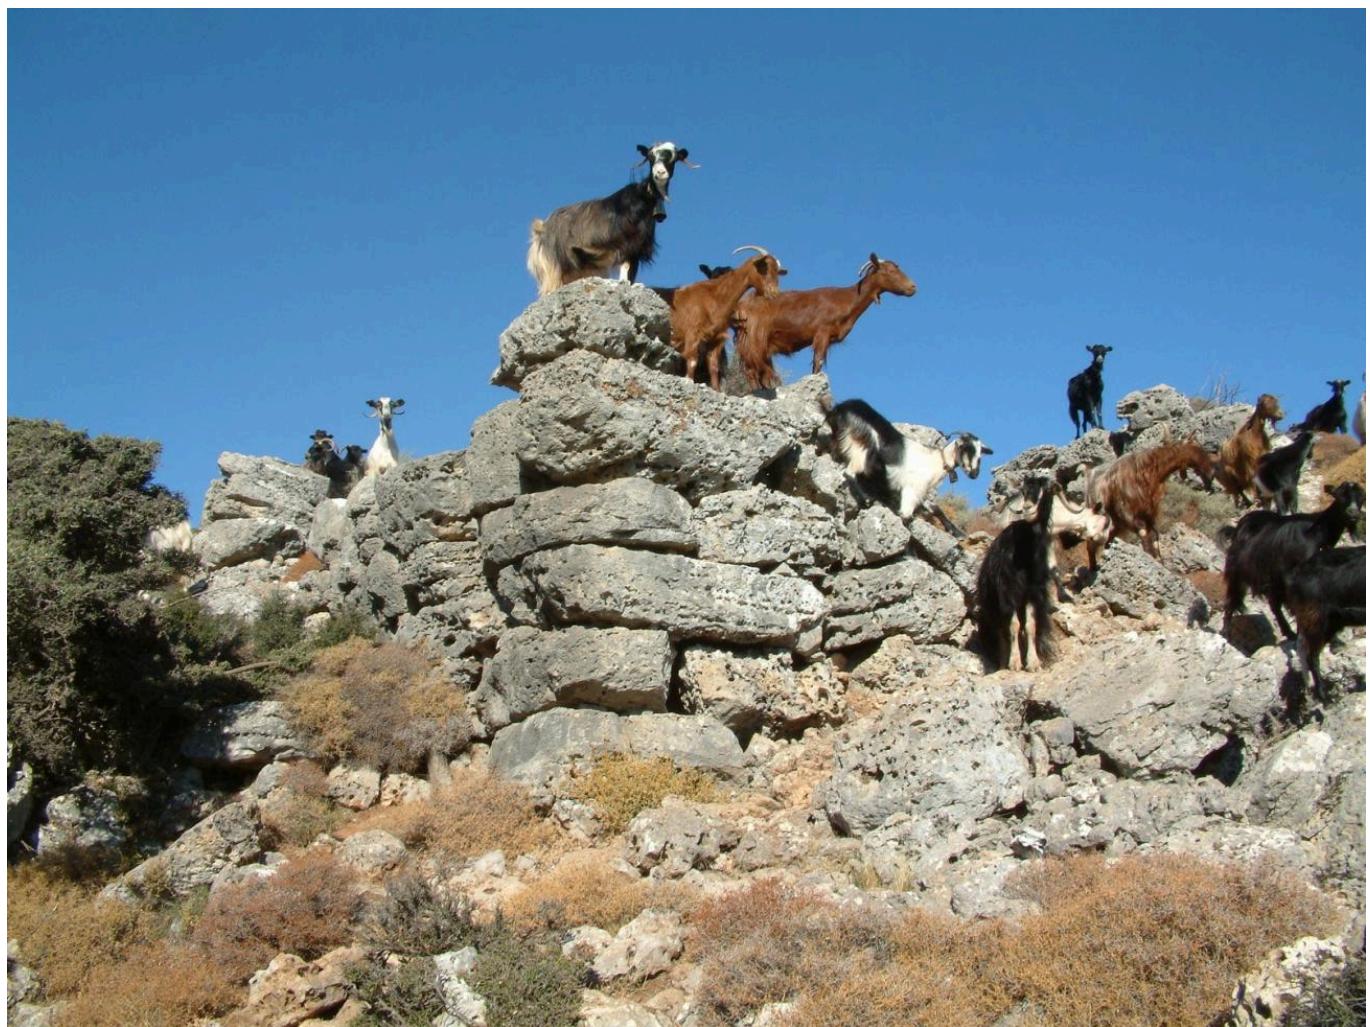
FIG 2. MIDDLE MINOAN ONCOLITHIC SITE, GOATS STANDING ON THE HORIZONTAL LEVEL OF THE RUIN INDICATING STEEPNESS OF SLOPE.

Apart from the preserved foundations of undressed massive blocks (See Figure 2), *ca.* 4000 years of the ruins' exposure to the Cretan high mountain climate (snow and rain in winter, heat in summer and wind year round) had left no upper structures. None of the ruins show traces of window openings in the sometimes high remaining foundations, while few door openings (*ibid.* 123) exist, the latter always on the upslope sides.

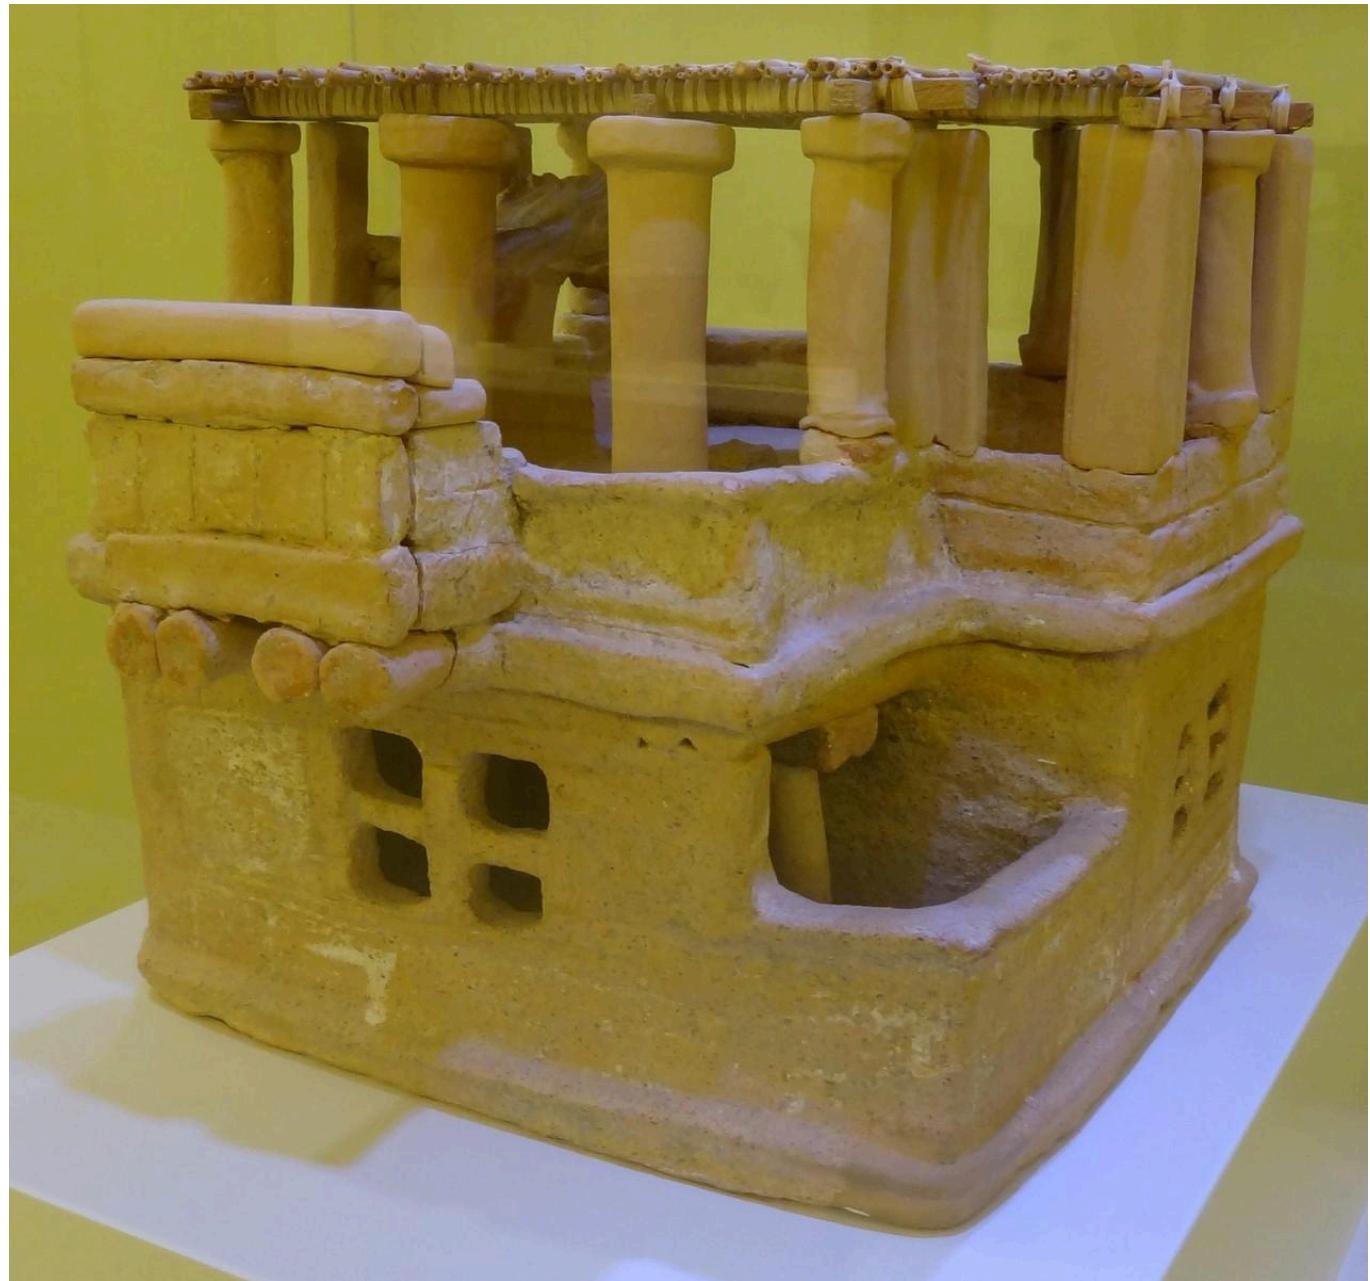
FIG 3. LATE MINOAN HOUSE MODEL FROM ARCHANES ([HTTPS://COMMONS.WIKIMEDIA.ORG/...](https://commons.wikimedia.org/))

Although we know of the mudbricks existence, the possible appearance of the houses has been informed by Late Minoan art such as the 'town mosaic' from Knossos and the small clay model house from Archanes (See Figure 3).

The Minoans seem to have regularly included a rather peculiarly shaped window in their houses, as observed in two of the walls (with four and six openings) of the Late Minoan house model from Archanes (See Figure 3).

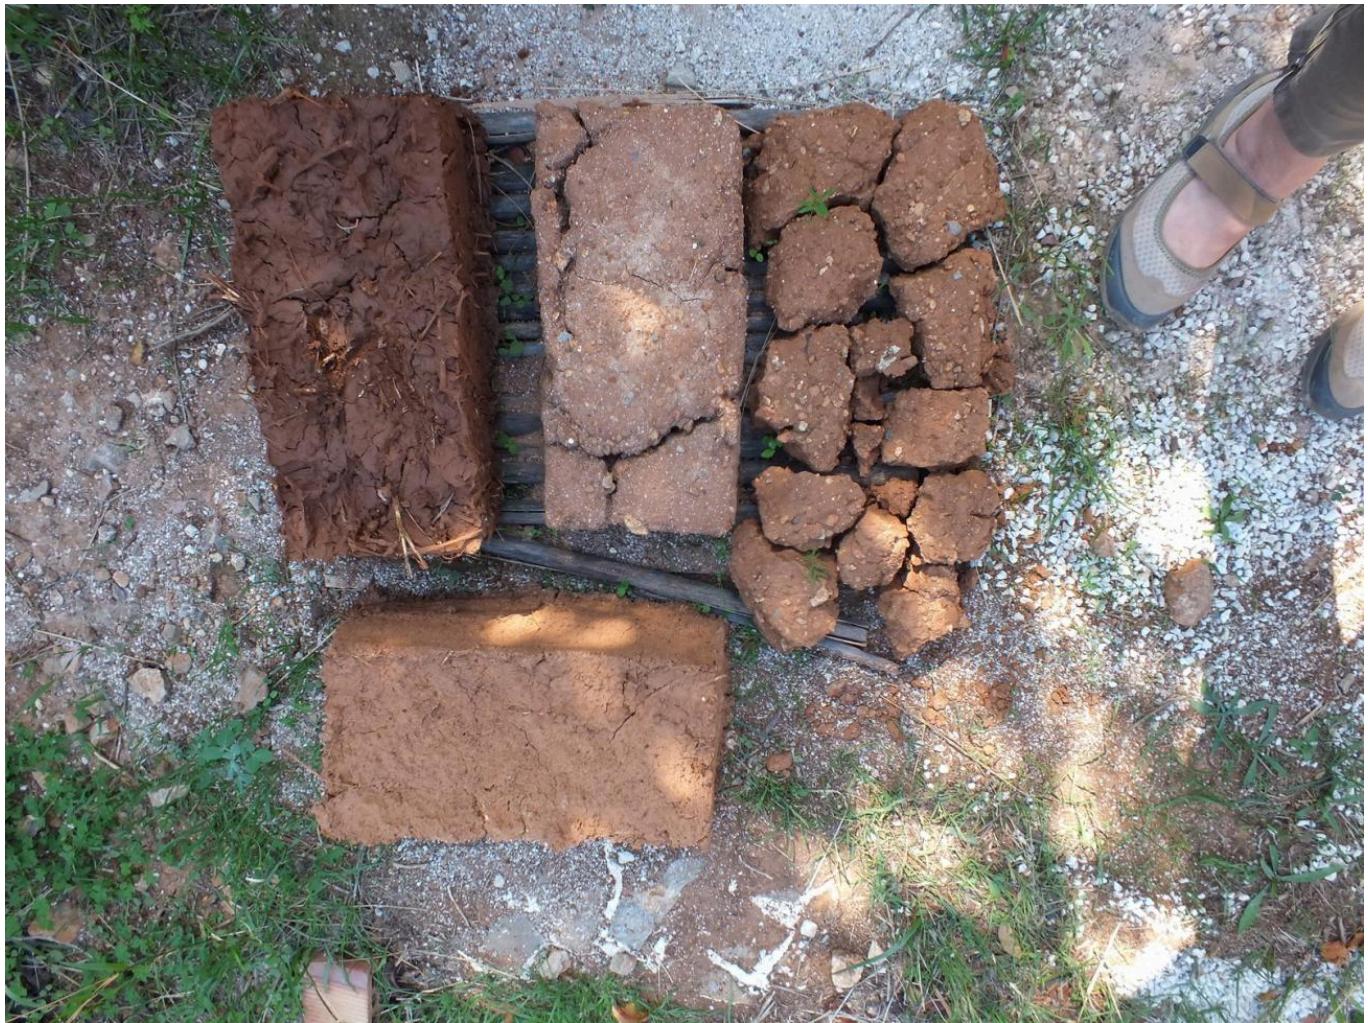
FIG 4. TEST BRICKS (FROM TOP LEFT): STRAW, SAND, PLAIN, PINE NEEDLES (CA. 4 WEEKS OLD)

For our experiment several varieties of bricks were tested (See Figure 4):

1. Plain mud: These broke into many small pieces after drying after two weeks.
2. Mud with ca. 30% sand: These also suffered several deep cracks within two weeks.
3. Mud with locally sourced pine needles: These produced a stable brick which remained damp and soft after two weeks; the needles had minimal filling ability, so the brick was comparatively heavy.
4. Mud with ca. 50 volume % wheat straw: The straw soaked up much of the mixing water within hours, so these bricks were useable, although slightly pliable – after two days in the sunDepending on the amount of plant temper used, the weight and temperature isolating abilities change naturally. I adjusted the mixture to a macroscopically roughly similar one with that visible in Malia Quartier Mu – cf. (See Figures 5-7)

1. Sand: Surface rounded by erosion but main mass partly intact, although with now widened cracks.
2. Pine needles: Surface slightly eroded, whole shape still intact, no cracks.
3. Plain: Nearly totally dissolved and hardly recognizable due to the many cracks that all enlarged the erodable surface.
4. Straw: About 0.5cm of surface eroded so that the straw temper is more visible, general shape intact (no cracks).

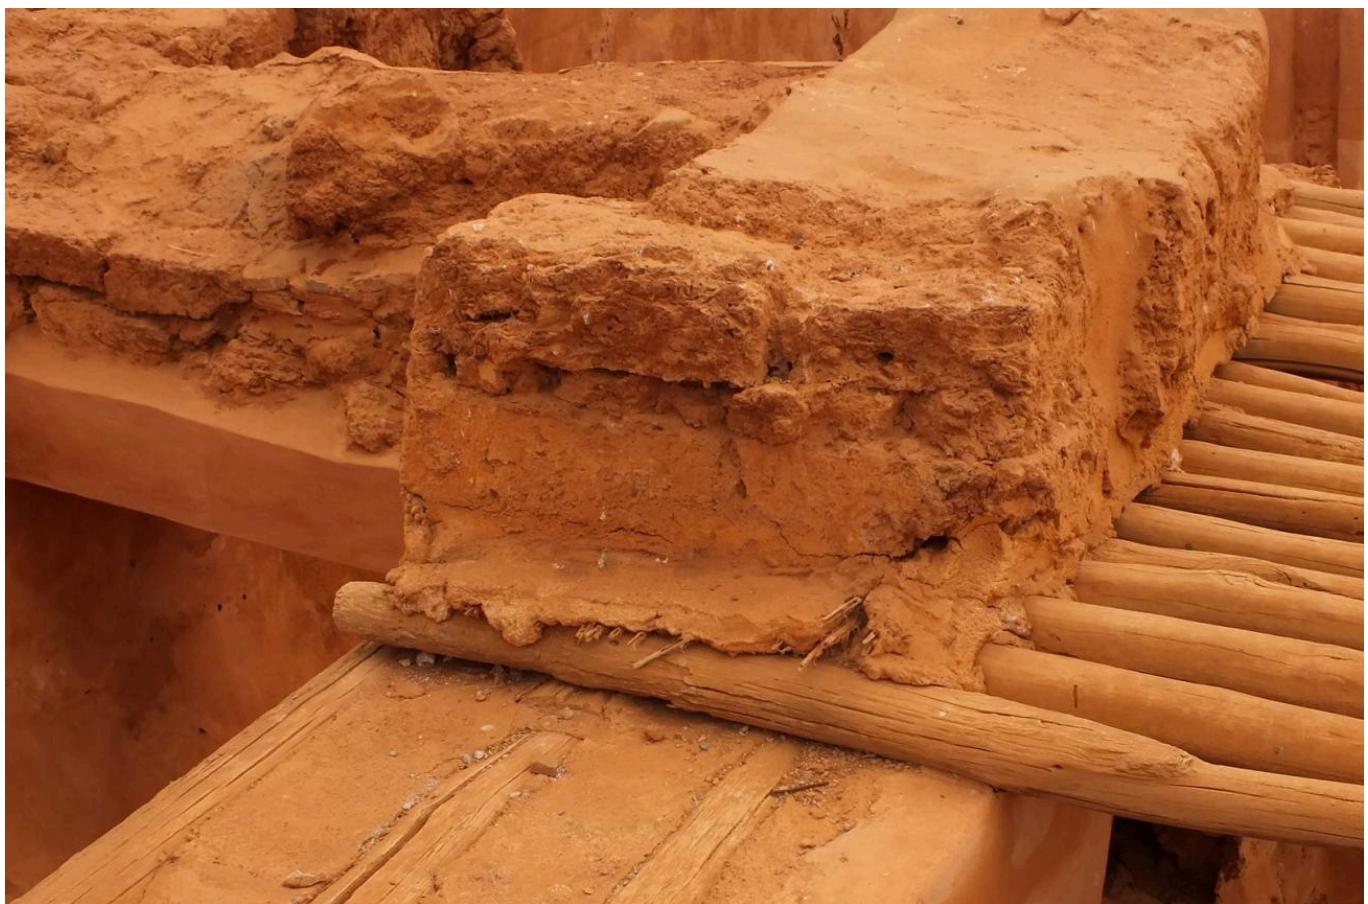
FIG 5. MUDBRICKS IN QUARTIER MU, MALIA (THE BEAMS – HERE AS FLOOR BASE FOR THE SECOND FLOOR - ARE RECONSTRUCTIONS FILLING THE VOIDS PRESERVED IN THE MUD PARTS OF THE RUINS). HEADERS AND STRETCHERS SEEM TO BE RANDOMLY MIXED.

We decided to follow the general lines of traditional Cretan houses, with a slight incline, which would allow rainwater to run off easily. This is also supported by the existence of roof drain spouts in Bronze Age Crete (Lenuzza 2013:84). These could not have functioned without a slight incline to the roof, while relative flatness would still allow a use of the roof-space for various activities. We chose timbers similar in size to those which we could have produced in the sites' surroundings. This also corresponded to the type of timber known from the voids visible in the Malia Quartier Mu houses (See Figure 5).

Because of this crookedness a vernacular house probably would not have had the beams as closely set as they were in urban Quartier Mu (See Figure 5). Also, the extremely heavy kermes oak beams in this dense packing would bring a large extra weight to the whole construction. Thus, and for economical reasons as mentioned above, we used imported pine timber. Similar timber might have been used in the Bronze Age mountain houses as they are partly situated in a pine forest that may have already existed 4000 years ago.

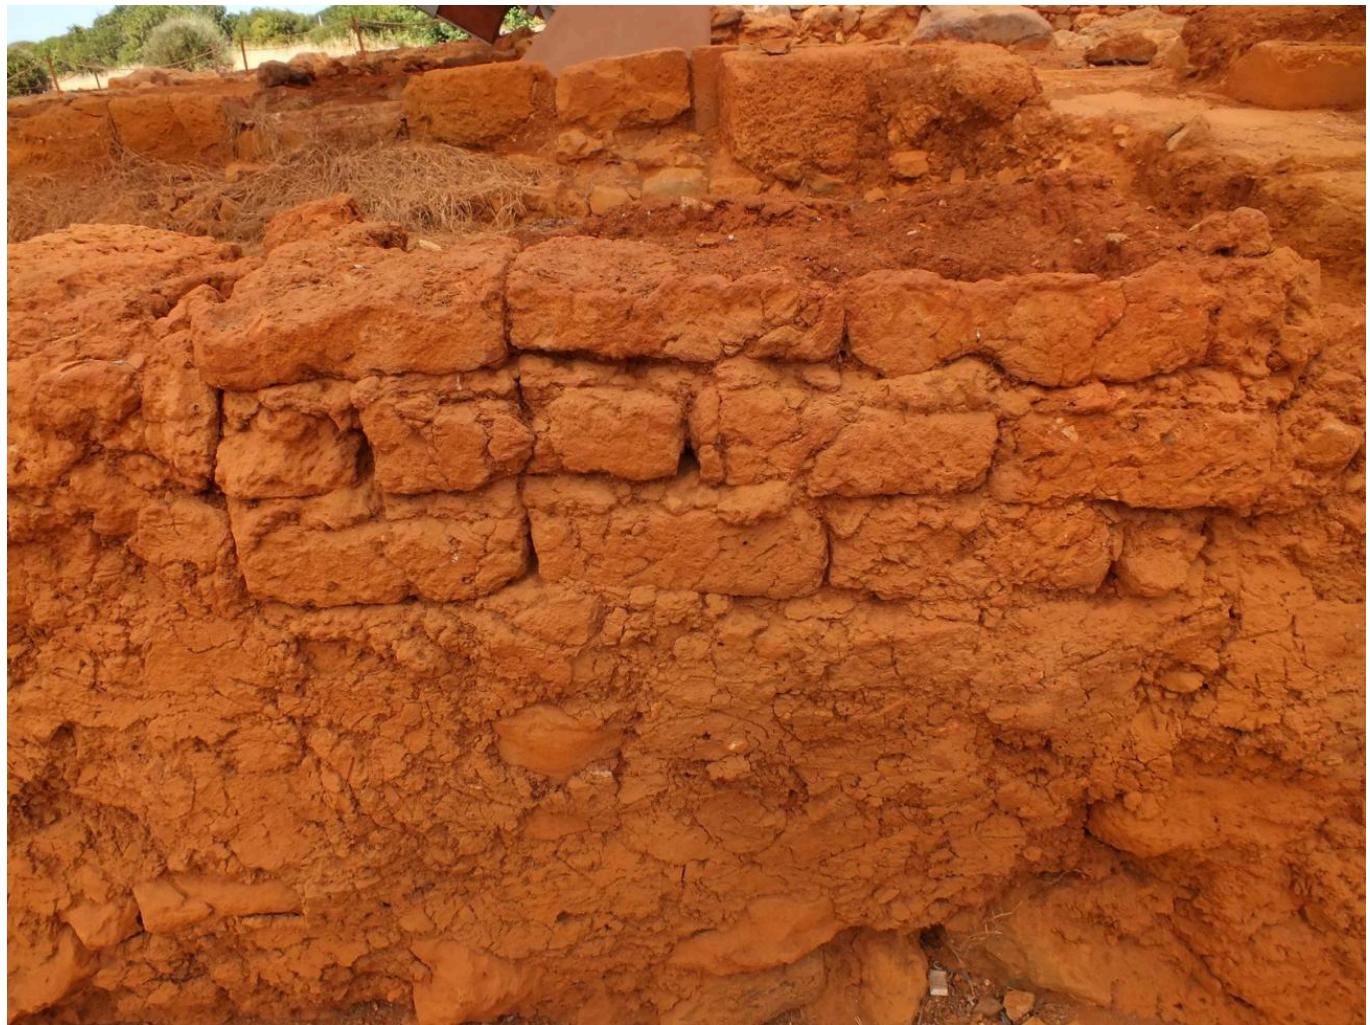
FIG 6. MALIA QUARTIER MU MUDBRICK WALL WITH SEVERAL PERPENDS ALIGNED.

also advisable to give the built bricks more time to dry and thus not be deformed too much by the weight of the following layers. For the mortar we used a mixture of *kouskouras* in the same mixing ratio as the bricks, but freshly made every day and thus more fluid for instant building. The straw for the mortar was chosen from shorter pieces than the brick mixture to improve its workability. As an easy Bronze Age parallel the use of mud mortar in Malia Quartier Mu is well visible e.g. in Figures 6 and 7.

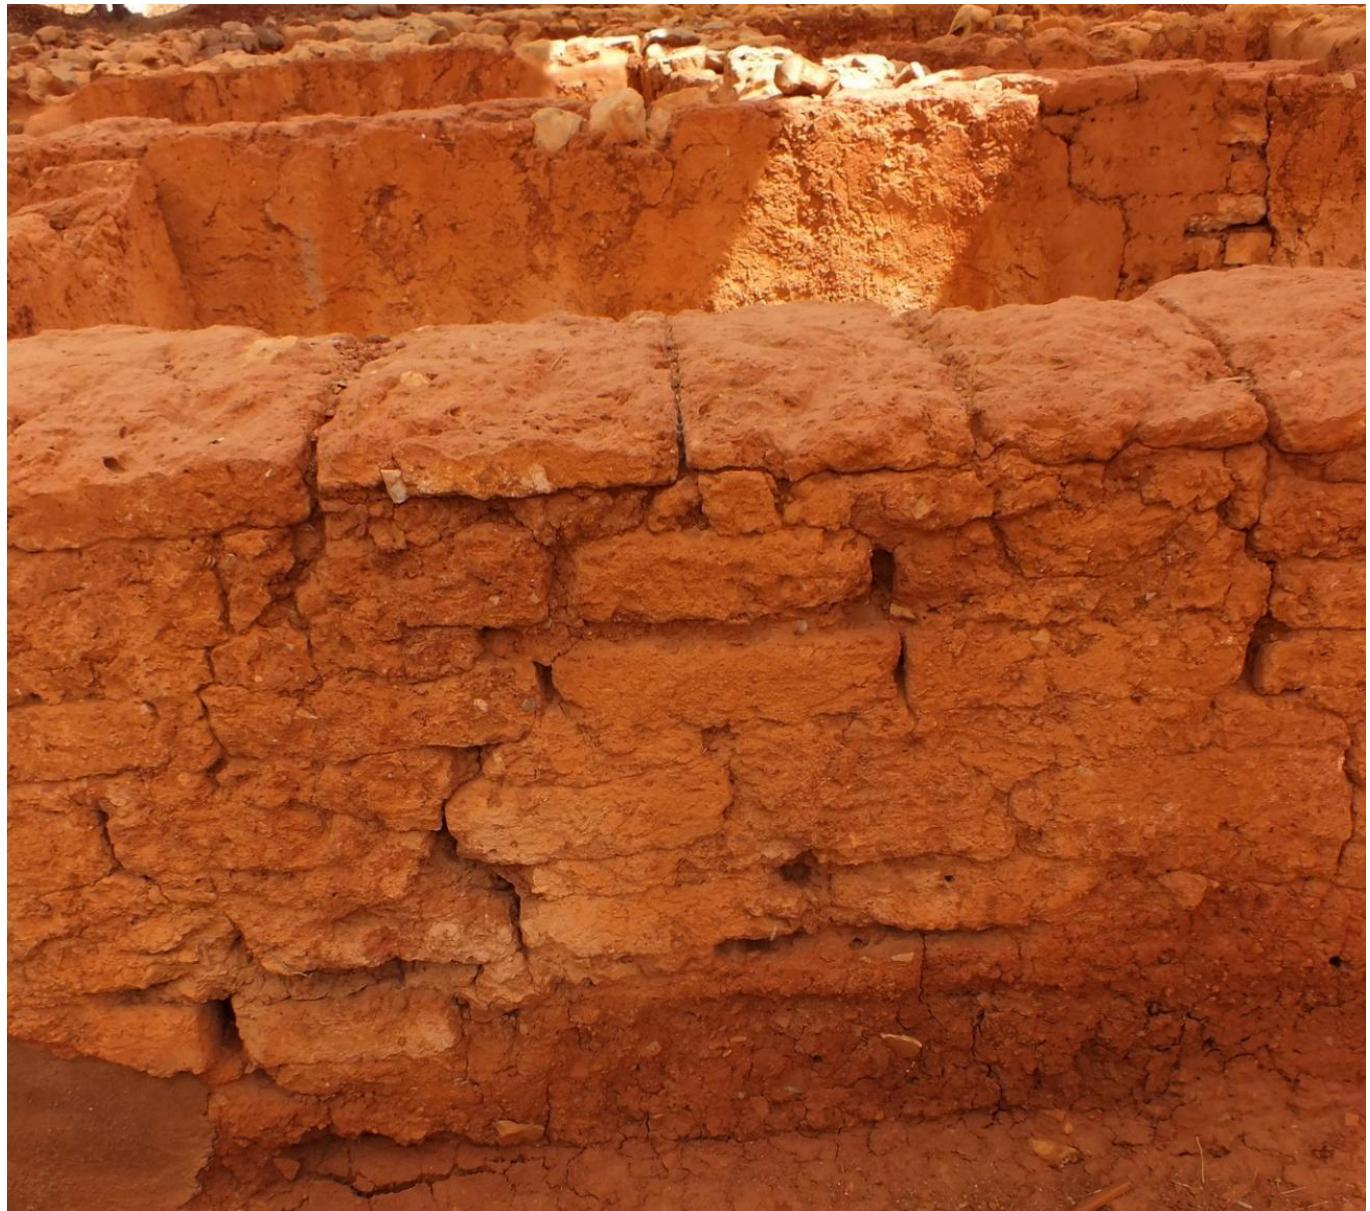
FIG 7. MALIA QUARTIER MU MUDBRICK WALL WITH OFFSET PERPENDS.

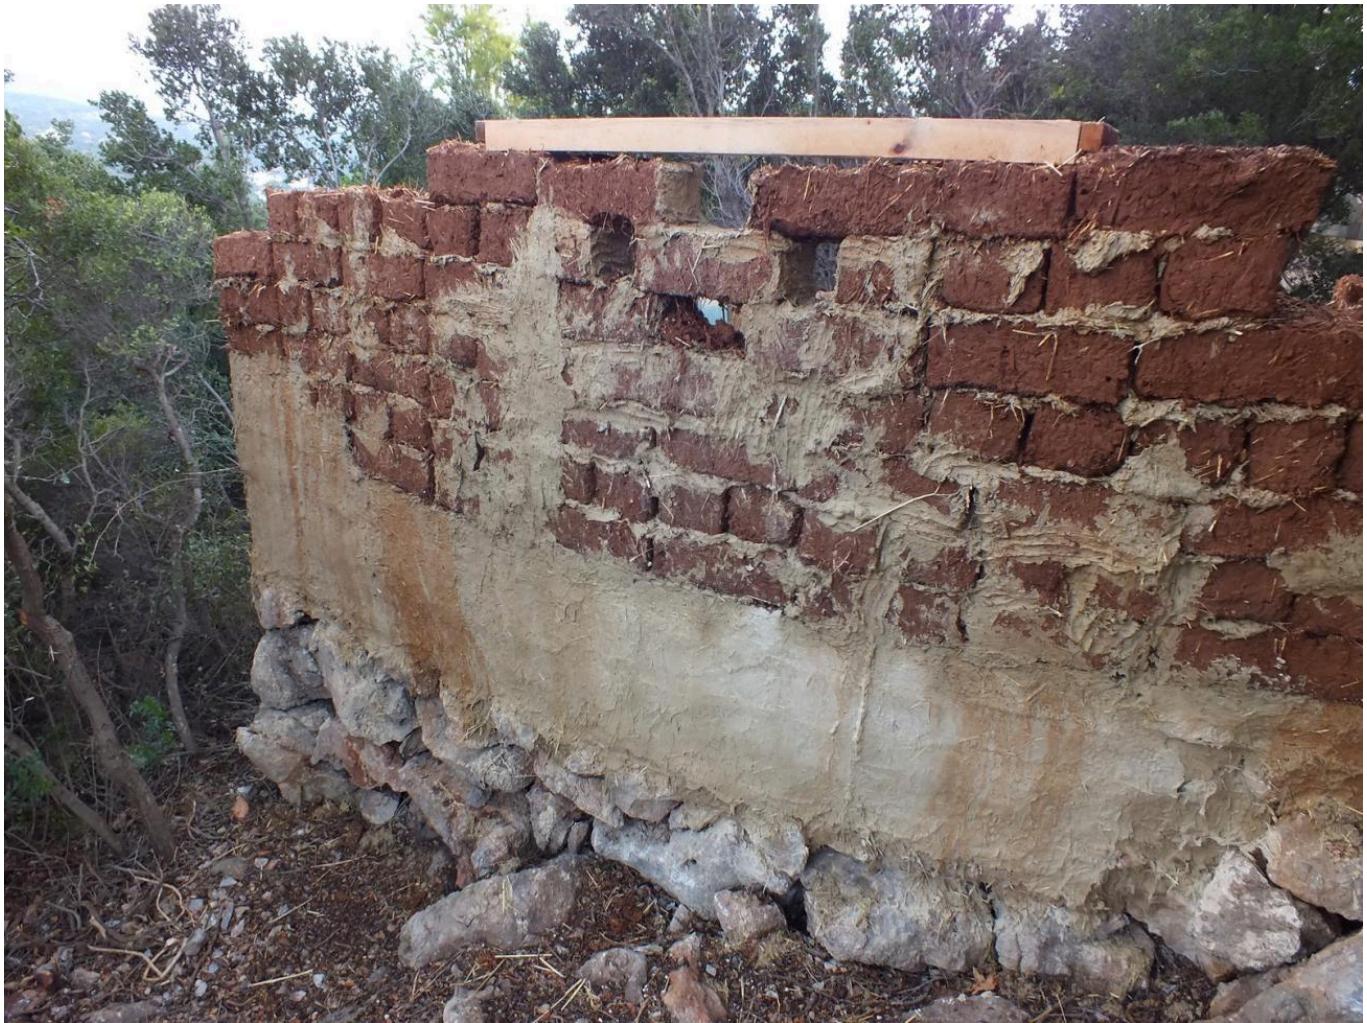
FIG 8. THE SOUTHERN WALL WITH THE "WINDOW" DURING THE FIRST RAIN, BRICKS BROWN, MORTAR AND PLASTER BEIGE, THE SLIGHT AMOUNT OF BRICK DISSOLVED BY RAIN IS VISIBLE AS DARKER STAINS ON THE BEIGE SURFACE (PRODUCED DURING CLOSING PERPENDS). THE FOUNDATION STONES ARE NOT FILLED IN.

As a base for mortar we used differently coloured clay that was recommended by a specialist in clay mortar (mainly baking ovens) due to its exceptional quality. Geologically it is a calcarious marl (for the geological details of Cretan soils see for example John A. Gifford in Shaw & Shaw 2014:59), and called *kouskouras* or *asprochoma* ("whitesoil") in Crete. It consists of a whitish, clayey, very dense and nearly totally waterproof when wet kind of soft stone. In situ our version seemed to be like "stone", although practically it is densely packed clay that when passed by a tractor with a plough turns into fine dust in summer - or deep mud in winter. It was sourced some 12 km from our site, and offered the advantage of clearly seeing the difference between the basic, red-brown bricks and the beige mortar and plaster (See

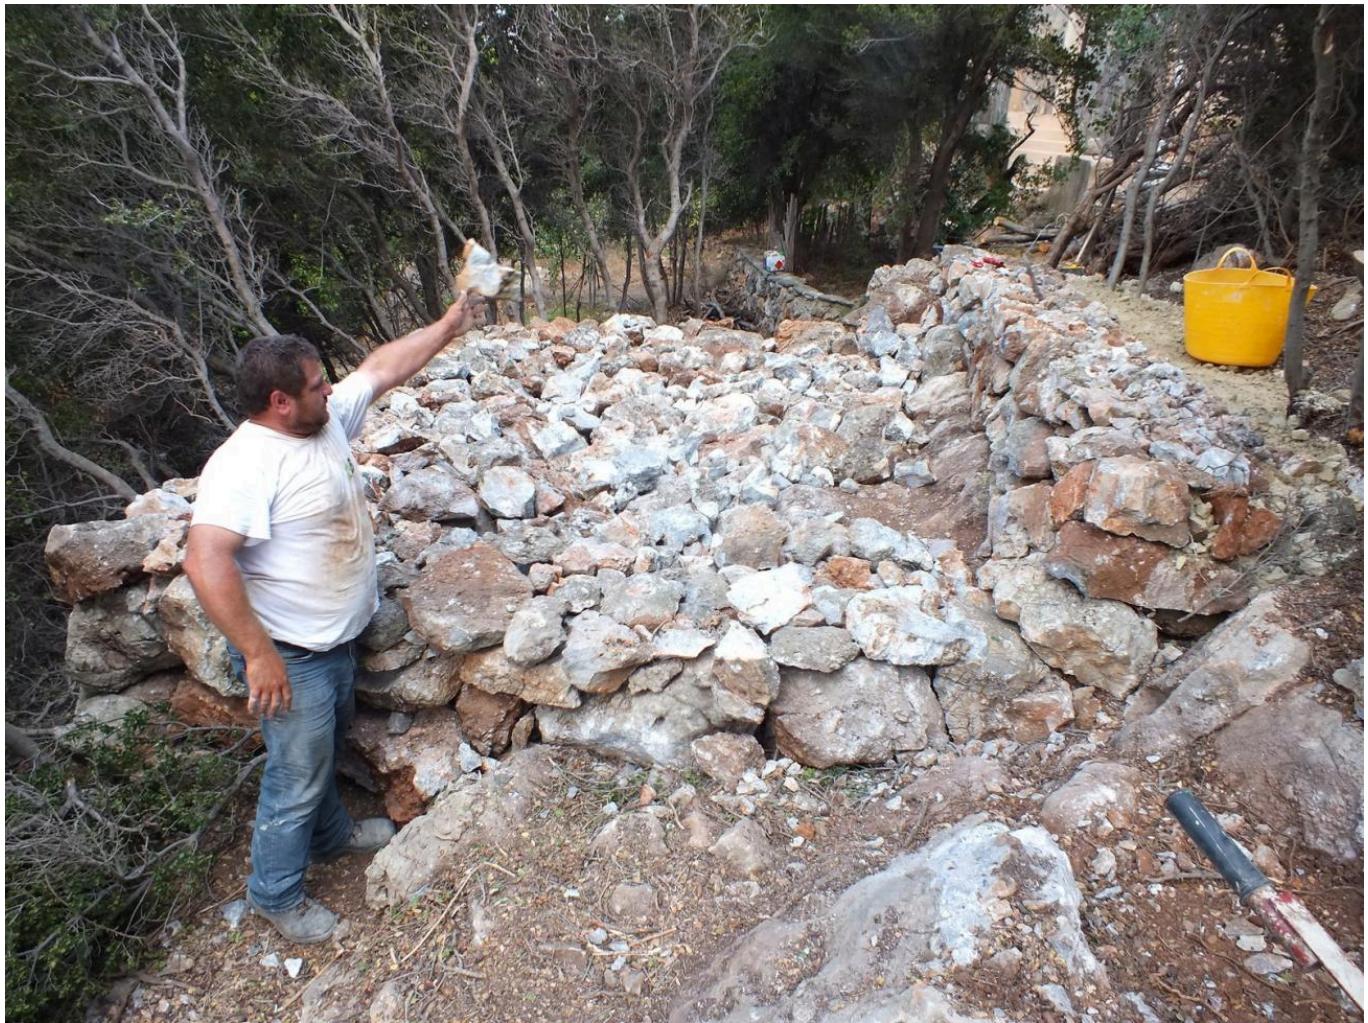
FIG 10. FILLING THE ONCOLITHIC FOUNDATION WITH RUBBLE AND THE UPSLOPE SIDE WITH WATERPROOFING CLAY OVER RUBBLE.

Having erected the frame of the foundation as much as possible in the Middle Minoan way (Beckmann 2012a, chapter 2, Beckmann 2012b:36-37c), we filled this with smaller stones. Some mountain houses may have used the space inside the foundation as a cellar *vel sim.*, while others were filled to create a level base for the upper structures (*ibid.*, and Figure 10).

Then, on top of that, we added several layers of waterproofing clay with an outward incline (See Figure 10, under the yellow bucket). Into the final layer, constructed for a clean surface only after the whole house was finished, we inserted with some 20cm distance from the final, plastered wall a shallow drainage channel (made from ridge-tiles) which has functioned perfectly since then (See Figure 27). Drainage channels like this are known from various ancient sites (see the list in Shaw 2004:173-4, n4).

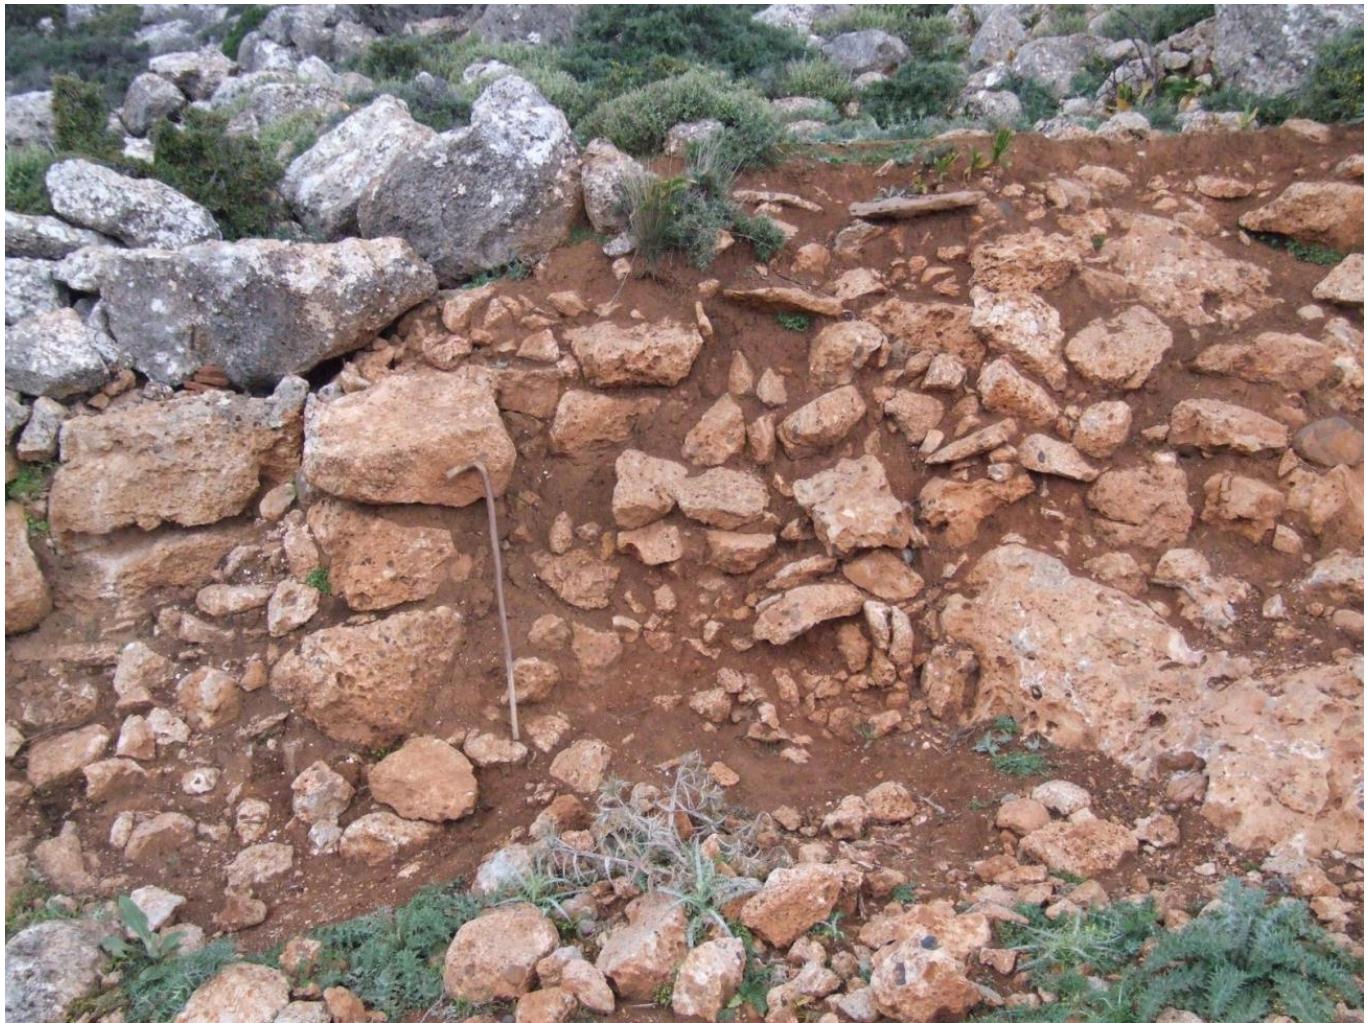
FIG 11. UPSLOPE PART OF A MIDDLE MINOAN RUIN ACCIDENTALLY CLEANED BY BULLDOZER (2008). THE SLABS IN THE SOIL RIGHT OF THE BIG FOUNDATION BLOCKS NEAR TO THE MODERN SURFACE MUST HAVE BEEN PART OF AN ANCIENT DRAINAGE CONSTRUCTION (CHANNEL?), MAY BE EVEN IN TWO PHASES. NOTE ALSO THE FILLING OF SMALL RUBBLE (FOR DRAINAGE AS WELL?) UNDERNEATH AND THE DEEP-REACHING FOUNDATION BLOCKS UNDER THE BUILDING'S CORNER (AT WALKING STICK, 90CM HIGH FOR SCALE).

The realization of this problem prompted me to return to one of the unexcavated prototype sites in the mountains, where an unauthorized bulldozer had scraped flush along the ruin wall and exposed the upslope part of the filling behind. Shortly after the bulldozing I had discovered that there were several stone slabs embedded in the soil close to the modern surface and hence probably not exactly in their original position. At the time, I had considered these to have been traces of an ancient flagged terrace or the like. When revisiting this site, unfortunately most of the originally clear-cut edge was gone and only one slab remained, so I reverted to my original, older photographs³. I could see now that the slabs must have been part of a construction diverting water from the house wall (See Figure 11). A good example to show of how well suited experimental archaeological work is to informing us about understanding ancient features.

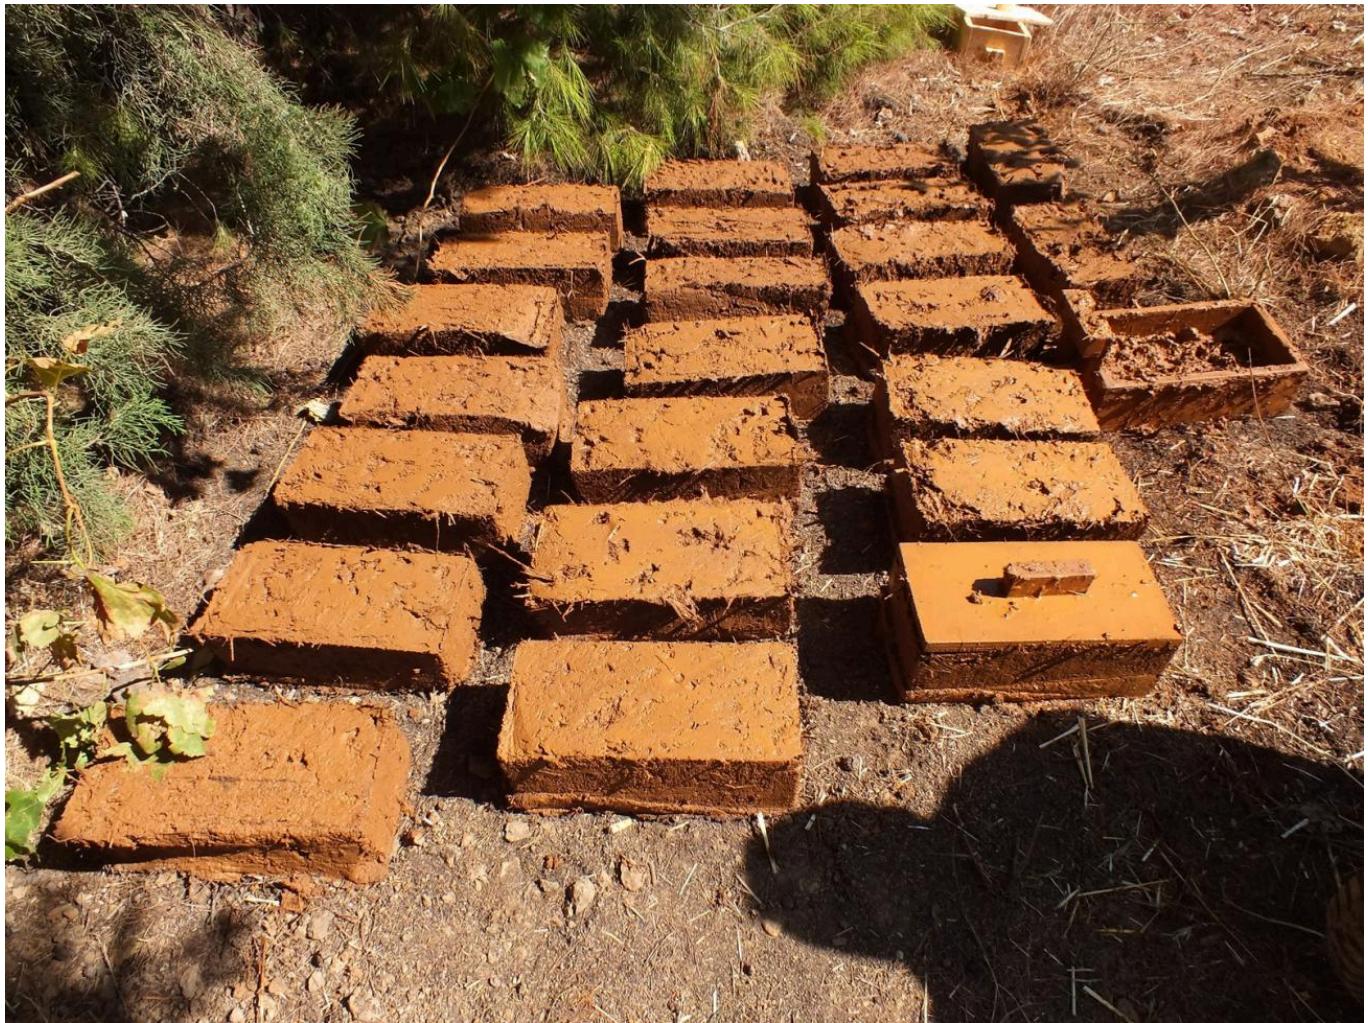
FIG 12. FINISHED MUDBRICKS WITH THE MOULD (CENTRE RIGHT) AND ITS LID THAT ALLOWED FOR EASIER PRESSING OF THE BRICK FROM THE MOULD (ON BOTTOM RIGHT BRICK).

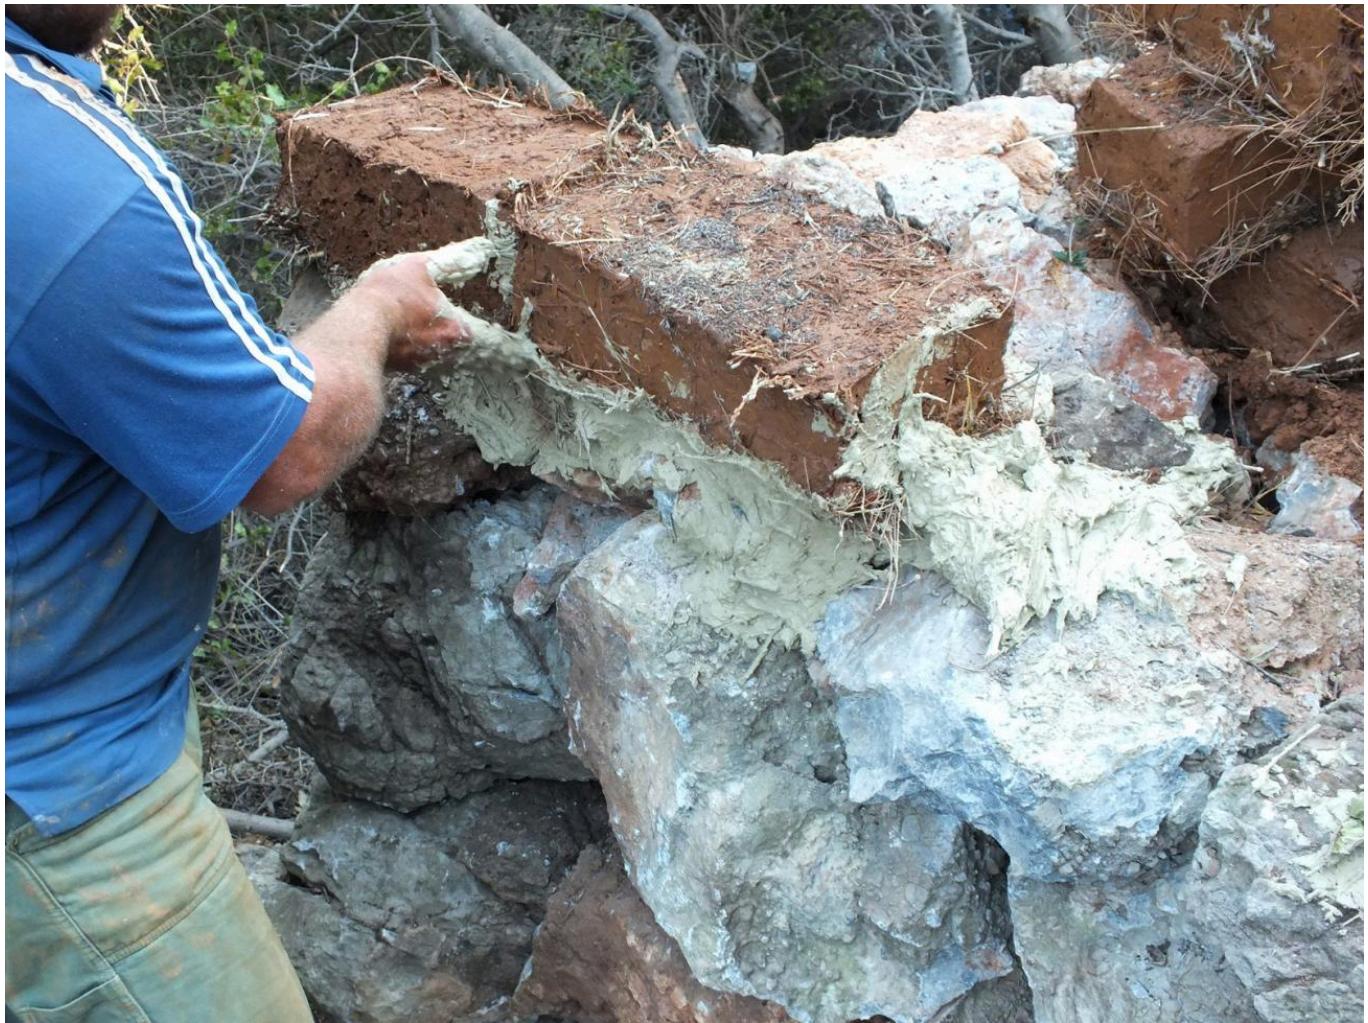
FIG 13. THE FIRST LAYER OF TWO DAY OLD MUDBRICKS, USING KOUSKOURAS-BASED MORTAR MIXED WITH FINER STRAW.

In the beginning, we produced this mixture in the traditional way by treading with our feet. After the first batch the workers suggested using a cement mixer for the clay-water mix, then pouring the mix over the straw in a wheelbarrow, mixing it by hand and then transporting the wheelbarrow to the space where the moulding and drying was carried out (See Figure 12). After two days, the mudbricks were dry enough (while still agreeably pliable) to be used in building (See Figure 13).

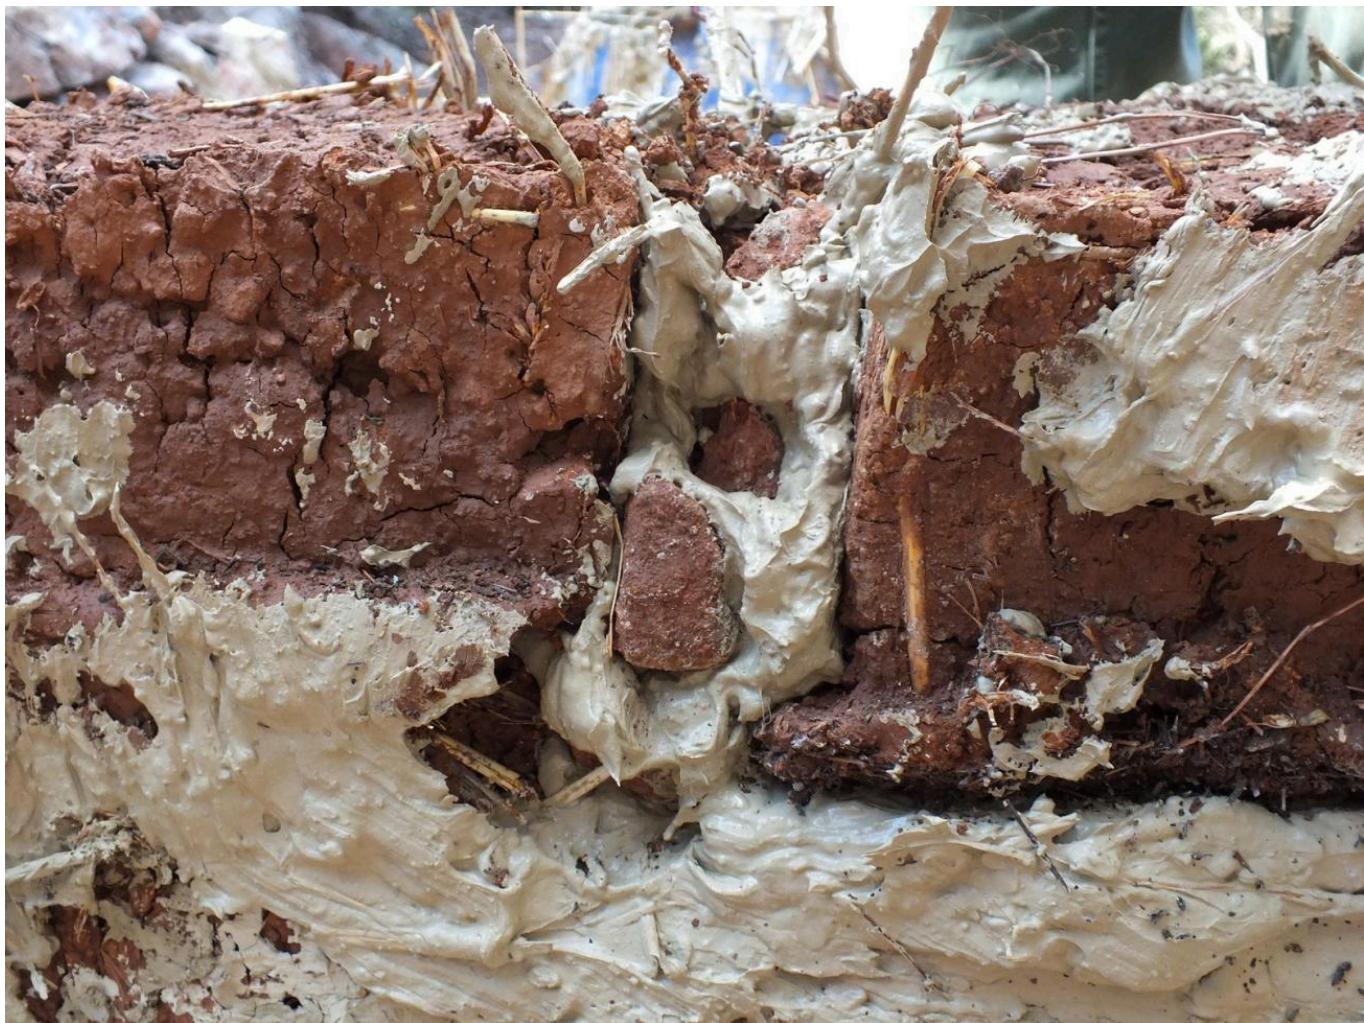
FIG 14. MUDBRICK WALL WITH KOUSKOURAS MORTAR USING ADDITIONAL STONES TO FILL GAPS.

In the following two layers of brick, some of the inequalities remaining from the first layer were adjusted where necessary, with more mortar and a few extra stones (as also visible in the Bronze Age wall in Malia, Figure 6), which were also used to fill other gaps (See Figure 14).
