A Minoan Experimental House – Paying Tribute to Middle Bronze Age Cretan Vernacular Architecture

EXARC Journal Issue 2016/4 | **Publication Date:** 2016-12-01

Author(s): Sabine Beckmann ¹

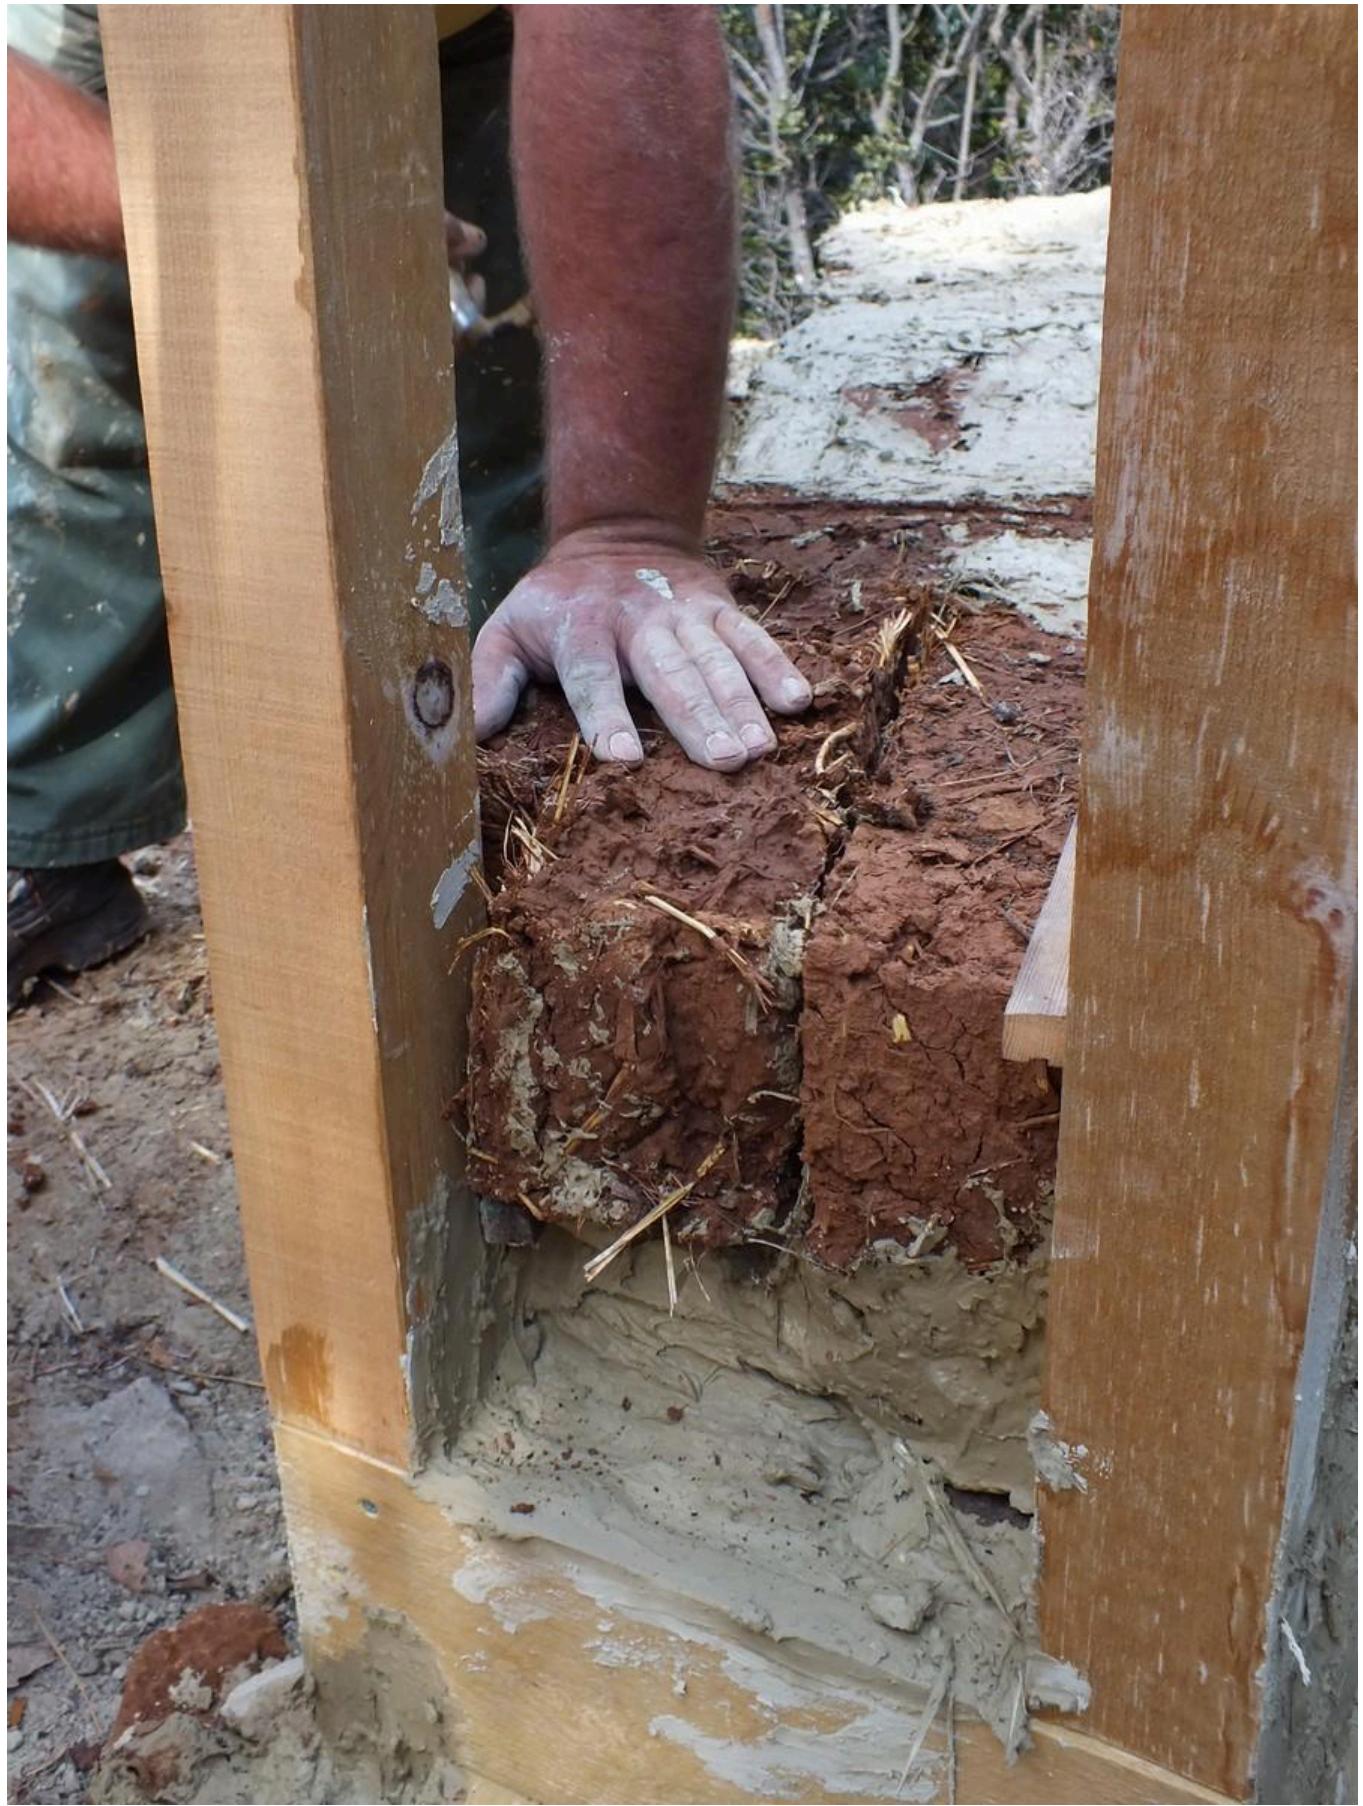
FIG 15. MUDBRICKS WITH CUT EDGES TO PROVIDE A BETTER BONDING WITH THE DOOR CASING.

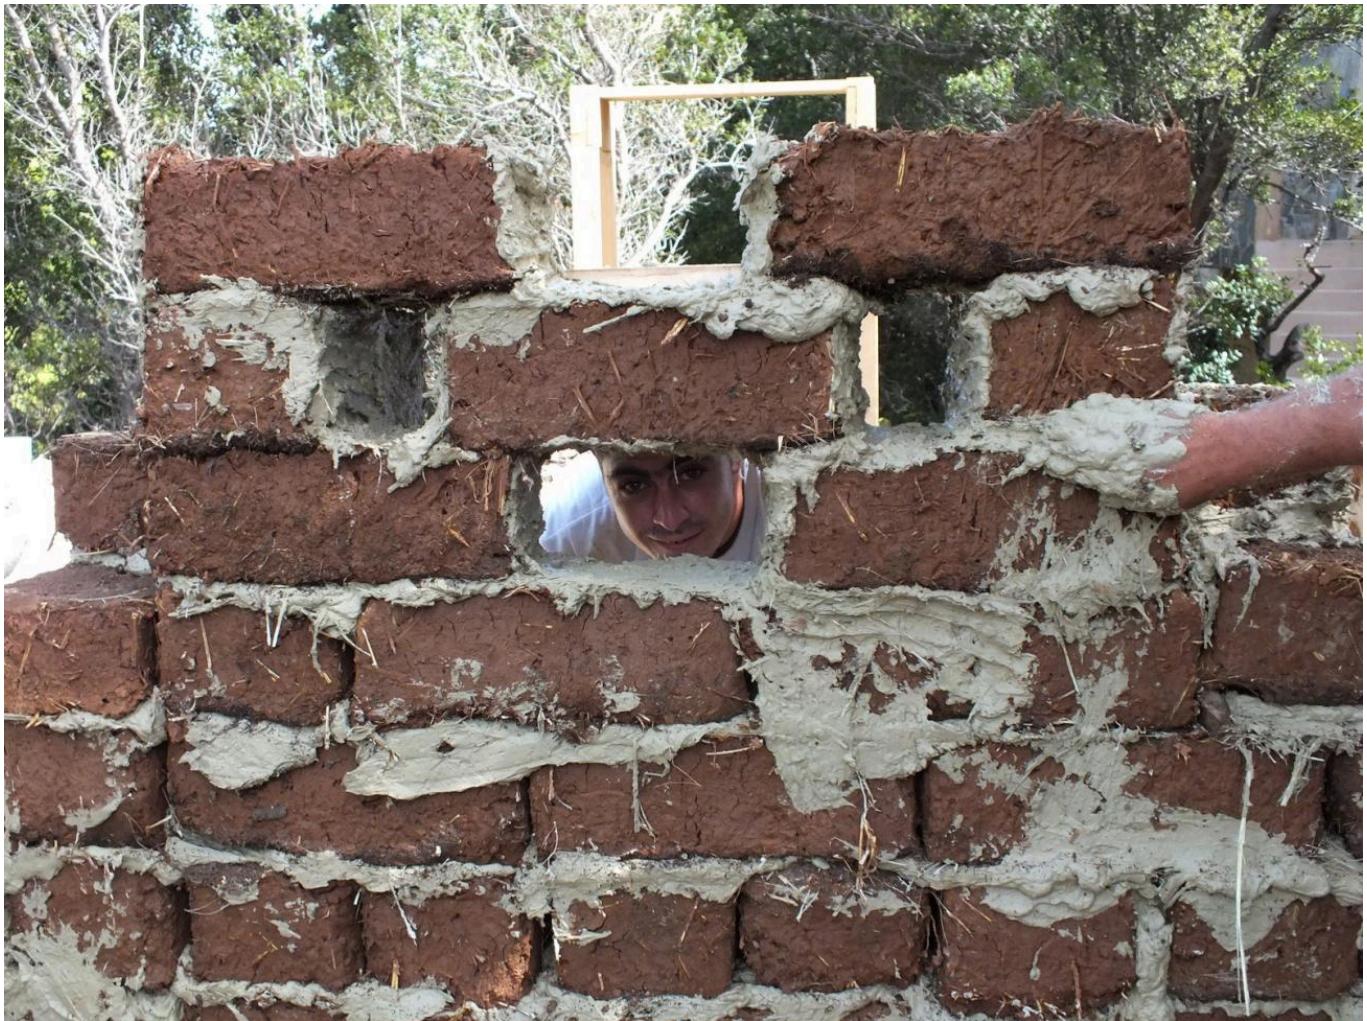
FIG 16. MINOAN STYLE "WINDOW" CREATED BY SPACING A SINGLE ROW OF BRICKS.

The workers ceased building layer by layer after the first few rows, and instead raised some parts higher than the rest, creating a stepped appearance (See Figure 16, 17). One evening when I revisited the construction site after everyone was gone, I noticed that they had left one loose brick lying on top of two others which had some space in between, next to one such stepped wall-part. The similarity in pattern with the Archanes model's windows was striking, and I realized how logically this kind of opening could be integrated into such a brick wall without large disturbances to the building process, and without giving up the stabilizing or weight-bearing qualities of the brick construction. Originally I had not planned to include any windows in the construction of such a small house - following ethnographic examples only a small opening for cross ventilation was scheduled.

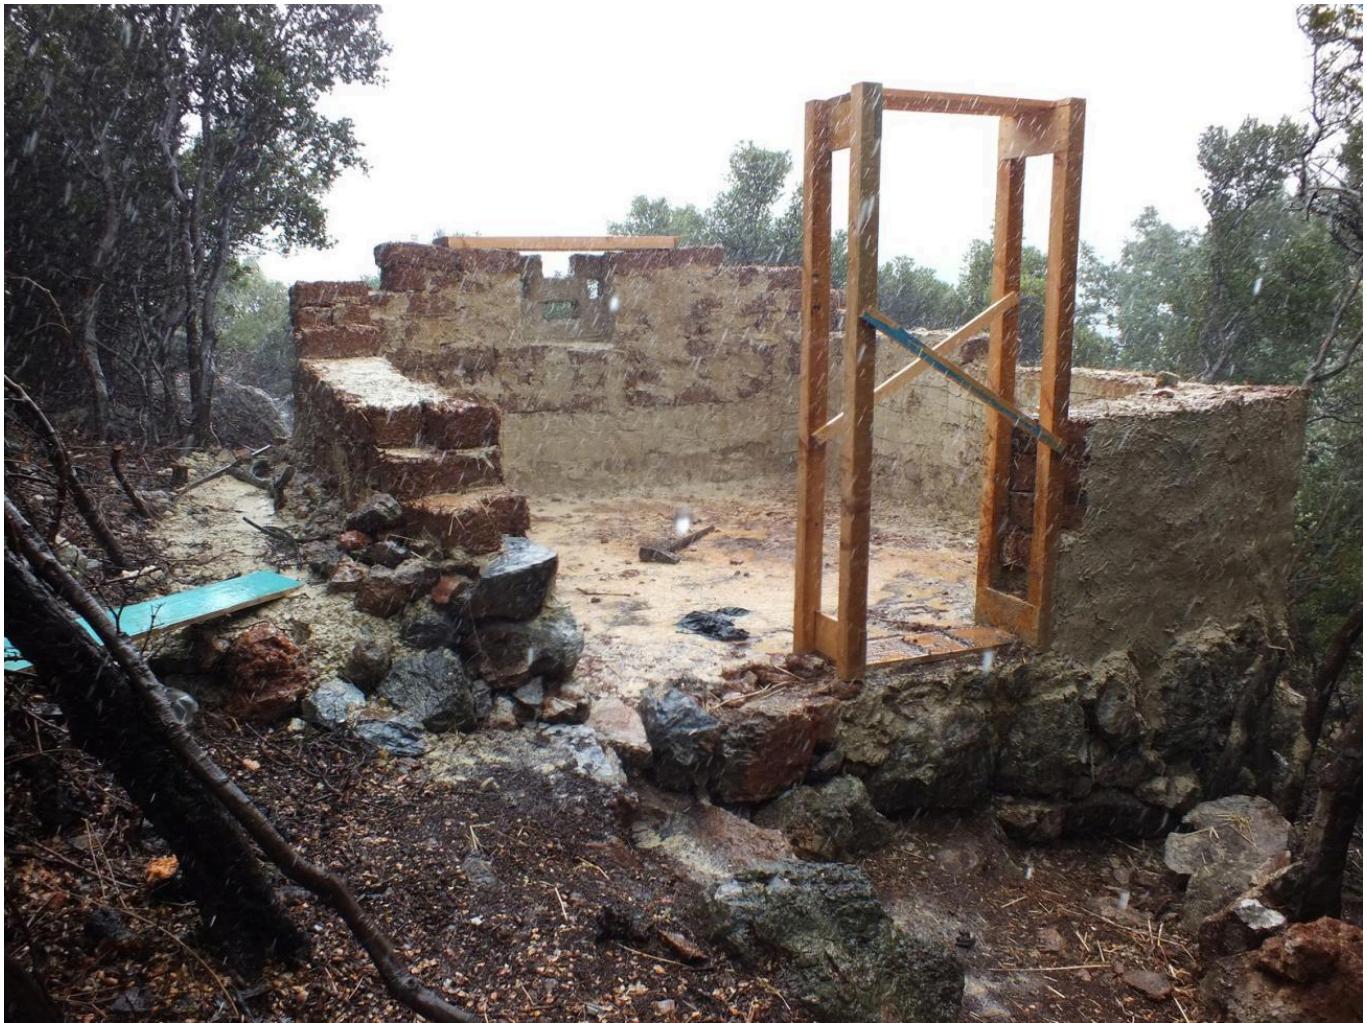
FIG 17. RAISING THE MUDBRICK WALLS -HEADER AND STRETCHER ALTERNATING- BUT NOT BY LAYER. THIS FIRST RAIN CAME EARLY IN 2014.

Subsequently, construction continued smoothly for a day – and then the unexpectedly early first rain came (See Figure 17), while the window-construction was only spanned by the timber lintel, to better spread the weight, that hadn't been integrated into the mudbricks yet.

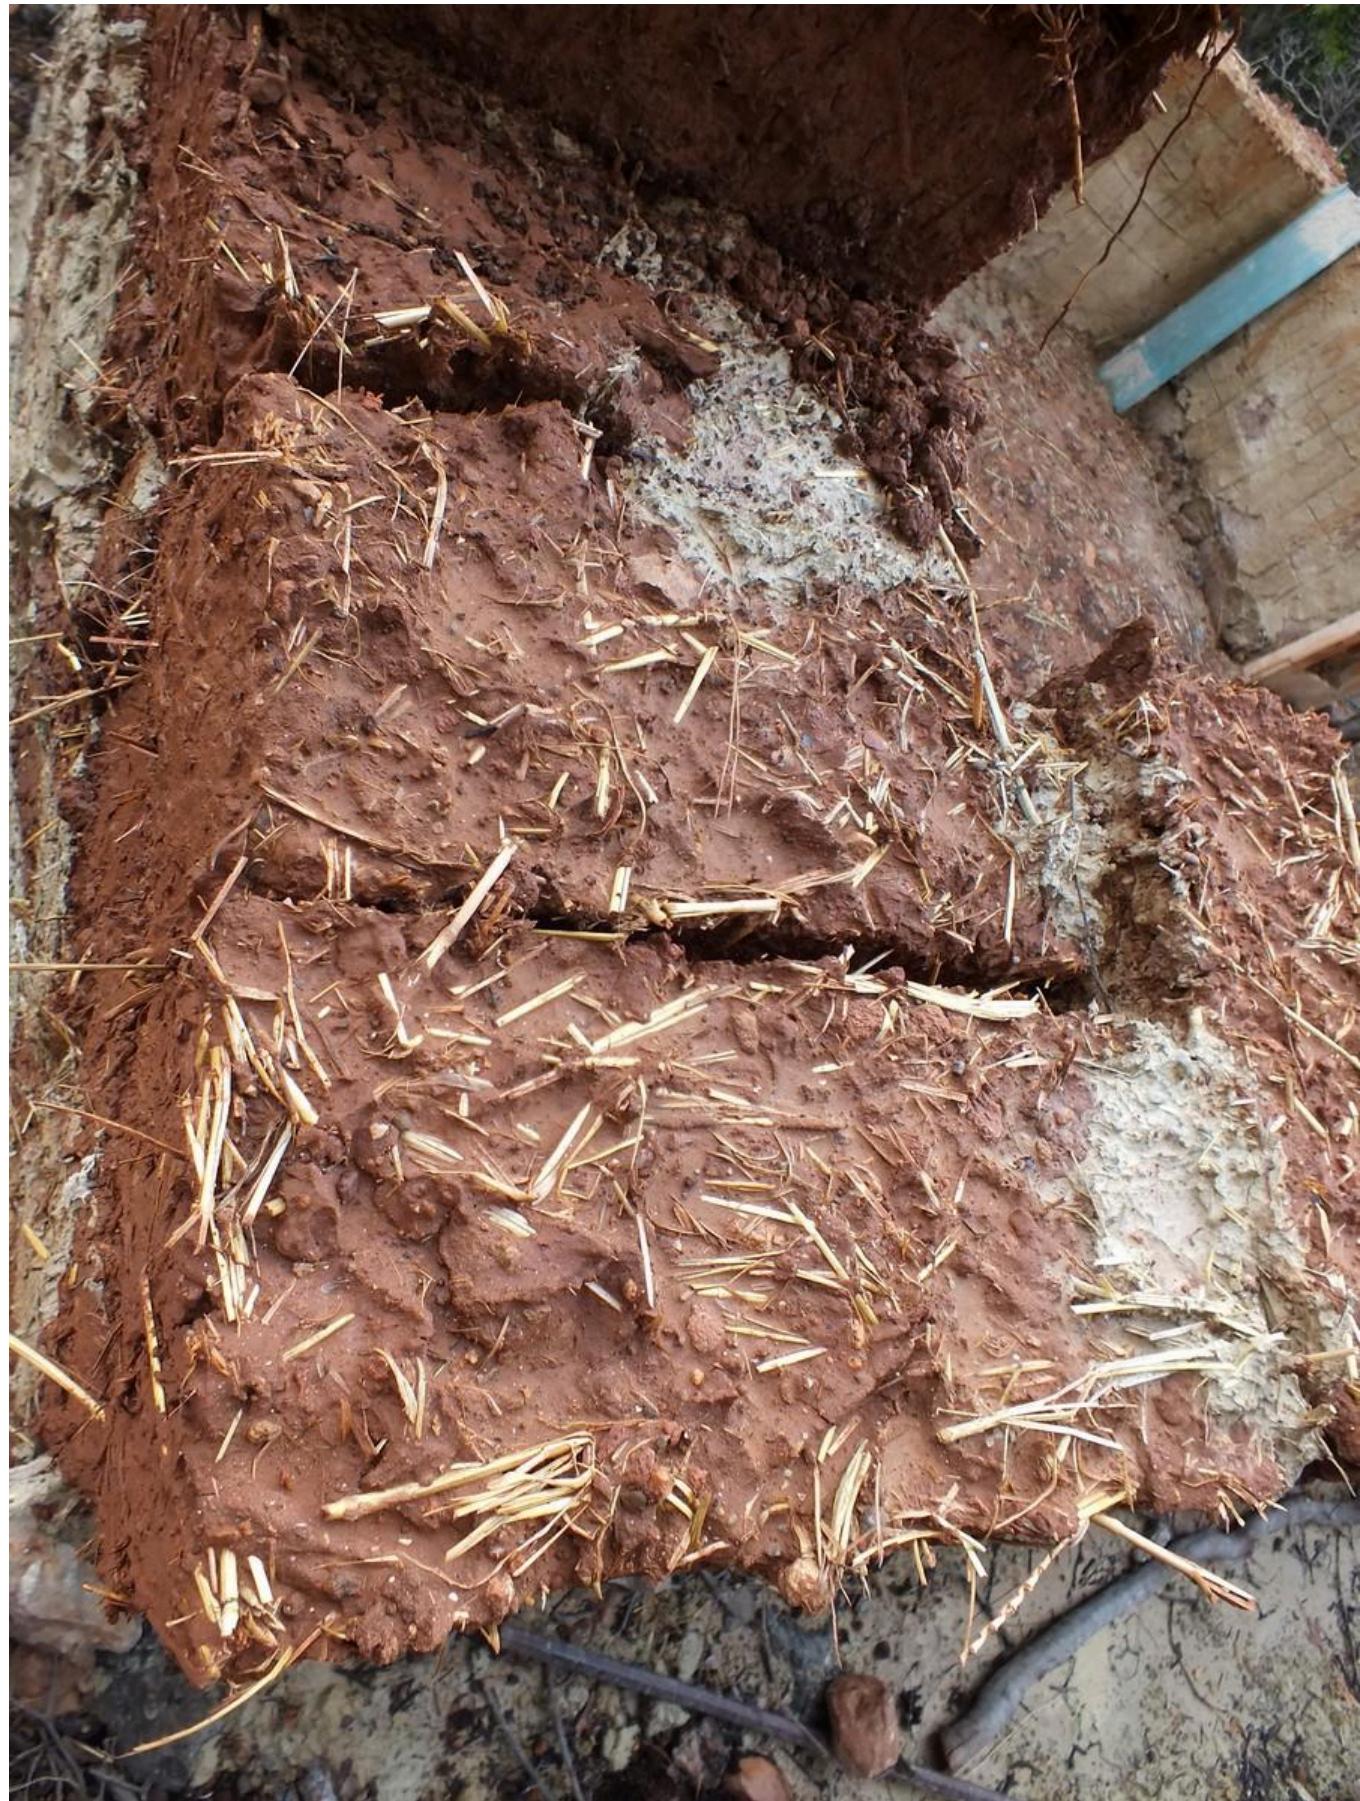
FIG 18. BUILT MUDBRICKS AFTER THE FIRST STRONG RAIN. THE SURFACE SHOWS ONLY SOME CLEAN-WASHED STRAW HAULMS.

Although everything appeared a sea of mud afterwards, the actual brick surfaces had hardly suffered at all (See Figure 18). This provided a first hint at how amazingly resistant this material seems to be to rain, even when still soft and with its surface exposed - something that would never happen again in the future, as long as the roof would remain intact.

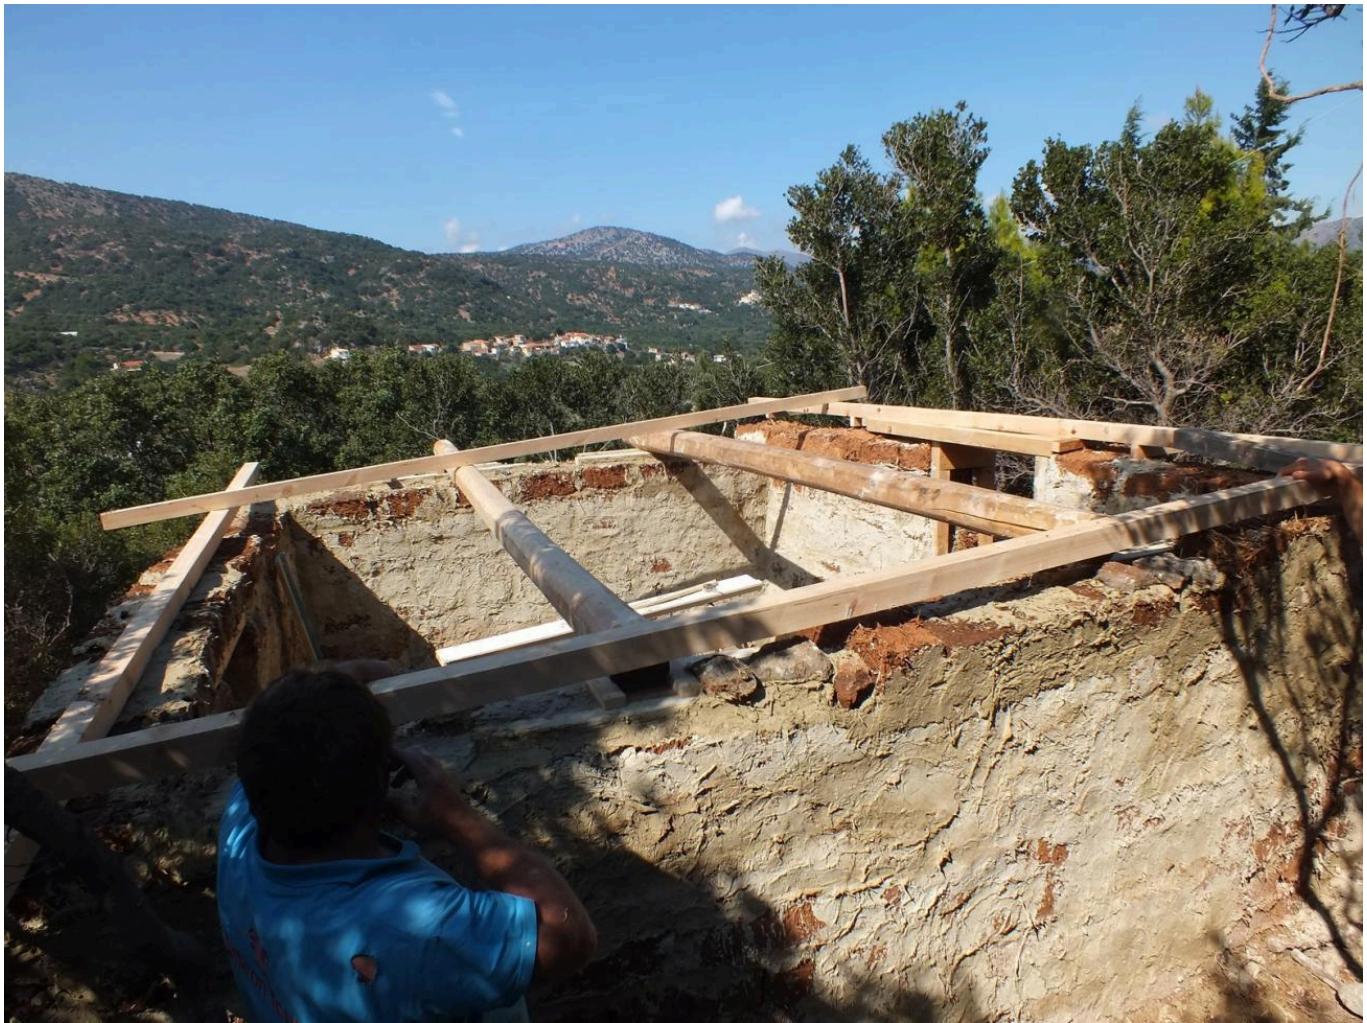
FIG 19. THE BASIC ROOF CONSTRUCTION - BEAMS BEDDED IN COB WITH A RINGBEAM ON TOP. THE SPACES UNDERNEATH ARE LATER FILLED WITH COB.

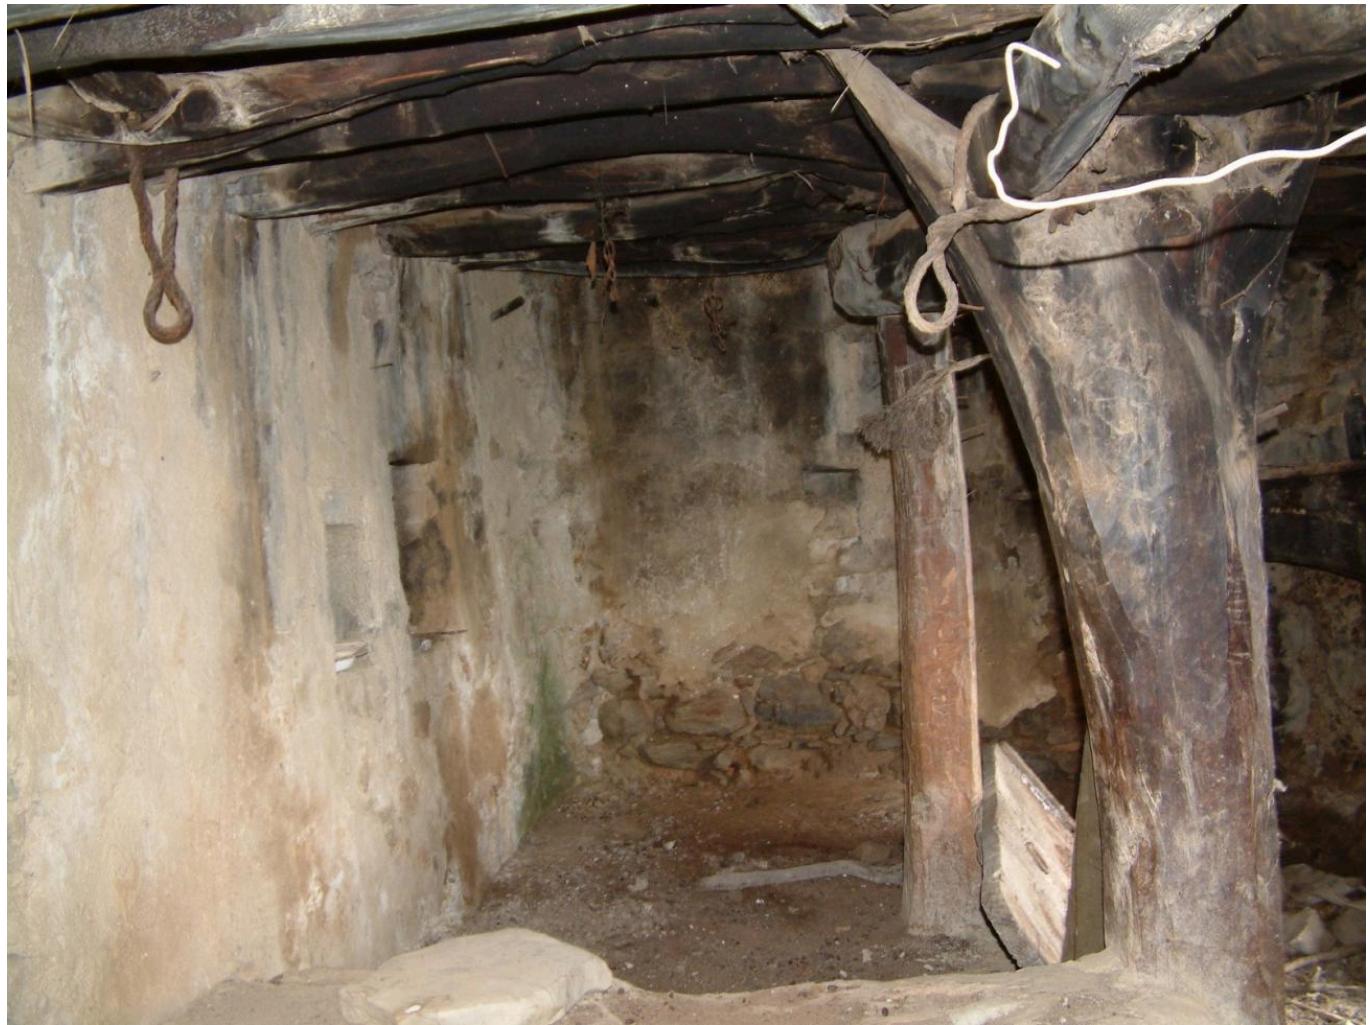
FIG 20. TRADITIONAL CRETAN ROOF CONSTRUCTION - THE TIMBER IS HERE PROBABLY OAK (SOOT-BLACKENED). THE WALLS ARE RUBBLE BUILT WITH MUD MORTAR, MUD PLASTER AND LIME PAINT.

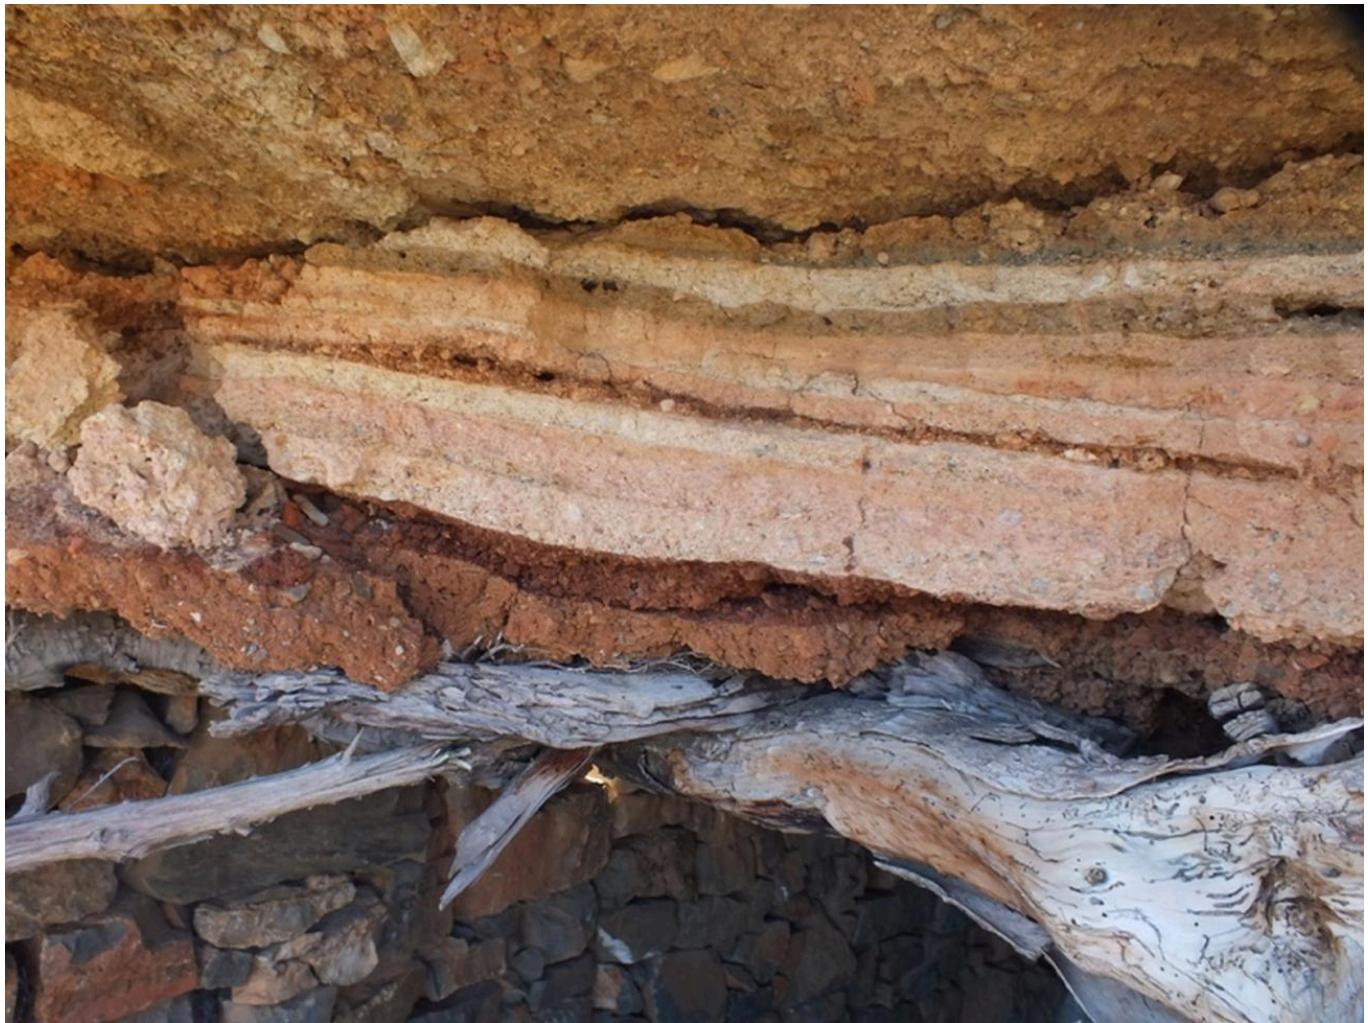
FIG 21. LAYERING IN A TRADITIONAL CRETAN ROOF (CURRENTLY CRUMBLING). ALL THE VISIBLE LAYERS WERE AT SOME POINT TOPPED WITH CEMENT WHICH PRESERVED THE STRATIGRAPHY USUALLY LOST.

As stated earlier, there is a paucity of knowledge as to how Middle Minoan roofs were constructed. Although the Late Minoan houses of urban Akrotiri on Santorini are preserved to an amazing height, archaeologists know little about their original roofs⁵, from the layering to the shape. Usually Minoan houses are supposed to have been flat, an assumption which may have to do with the shape of traditional Cretan houses as much as the traces known from floor constructions in multi-storey Bronze Age urban houses (See Figure 5). The only certainty is the absence of any kind of tiles or slabs covering the Minoan mountain dwellings, as not a single building of the 337 ruins examined showed traces of tiles. It seems as if the few published cases of roof layering – irrespective of the roofs' slope – have a similarity with traditional Cretan roofs (Lenuzza 2013:80) as visible in Figure 21.

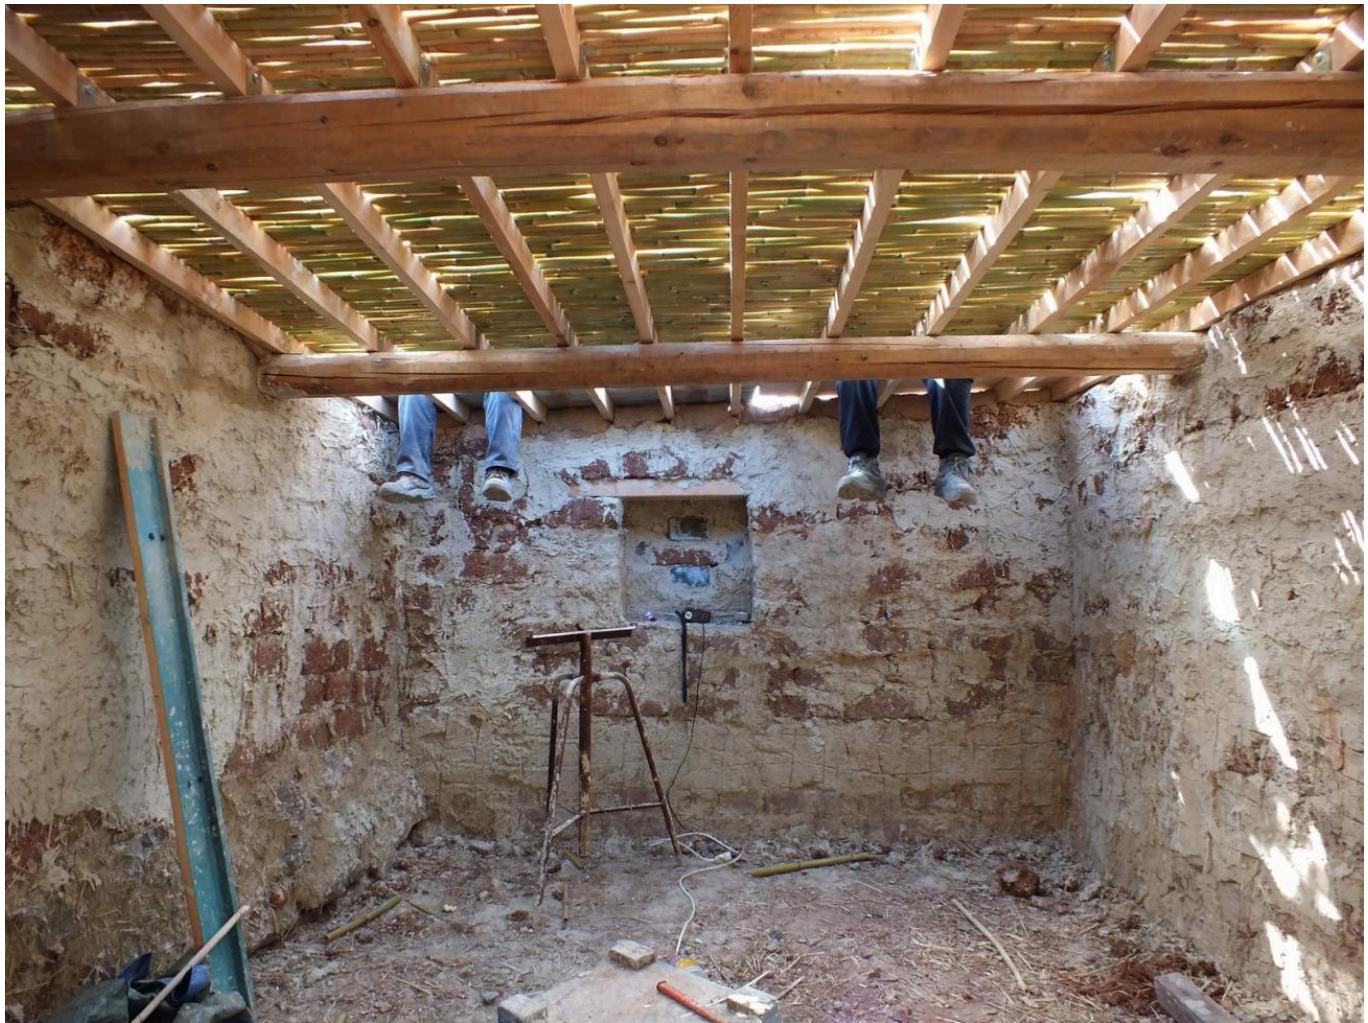
FIG 22. THIN BEAMS AND GIANT CANE AS FIRST ROOF LAYERS OVER THE MAIN BEAMS.

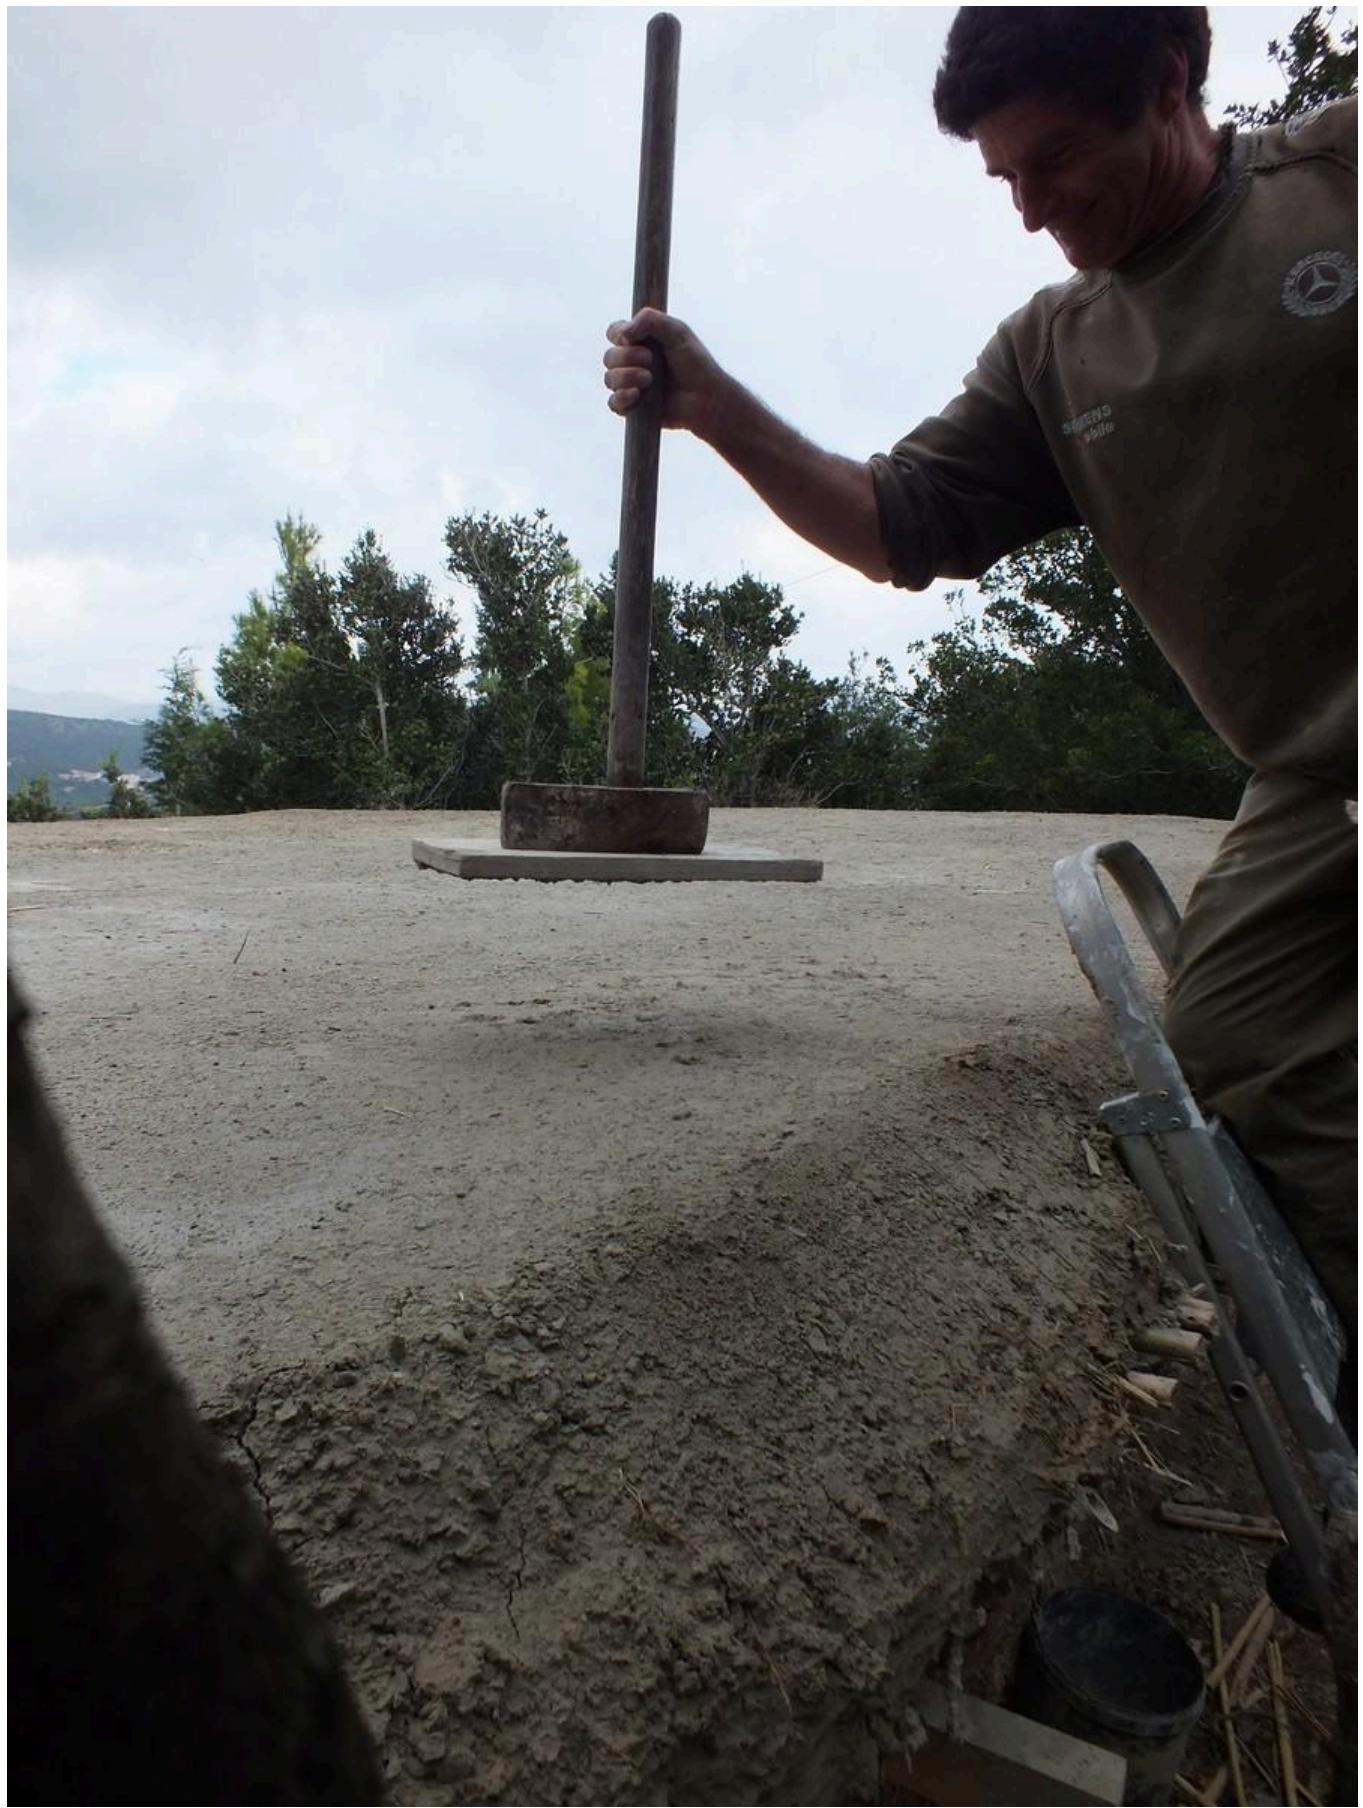
FIG 23. COMPRESSING THE LAST ROOF LAYER.

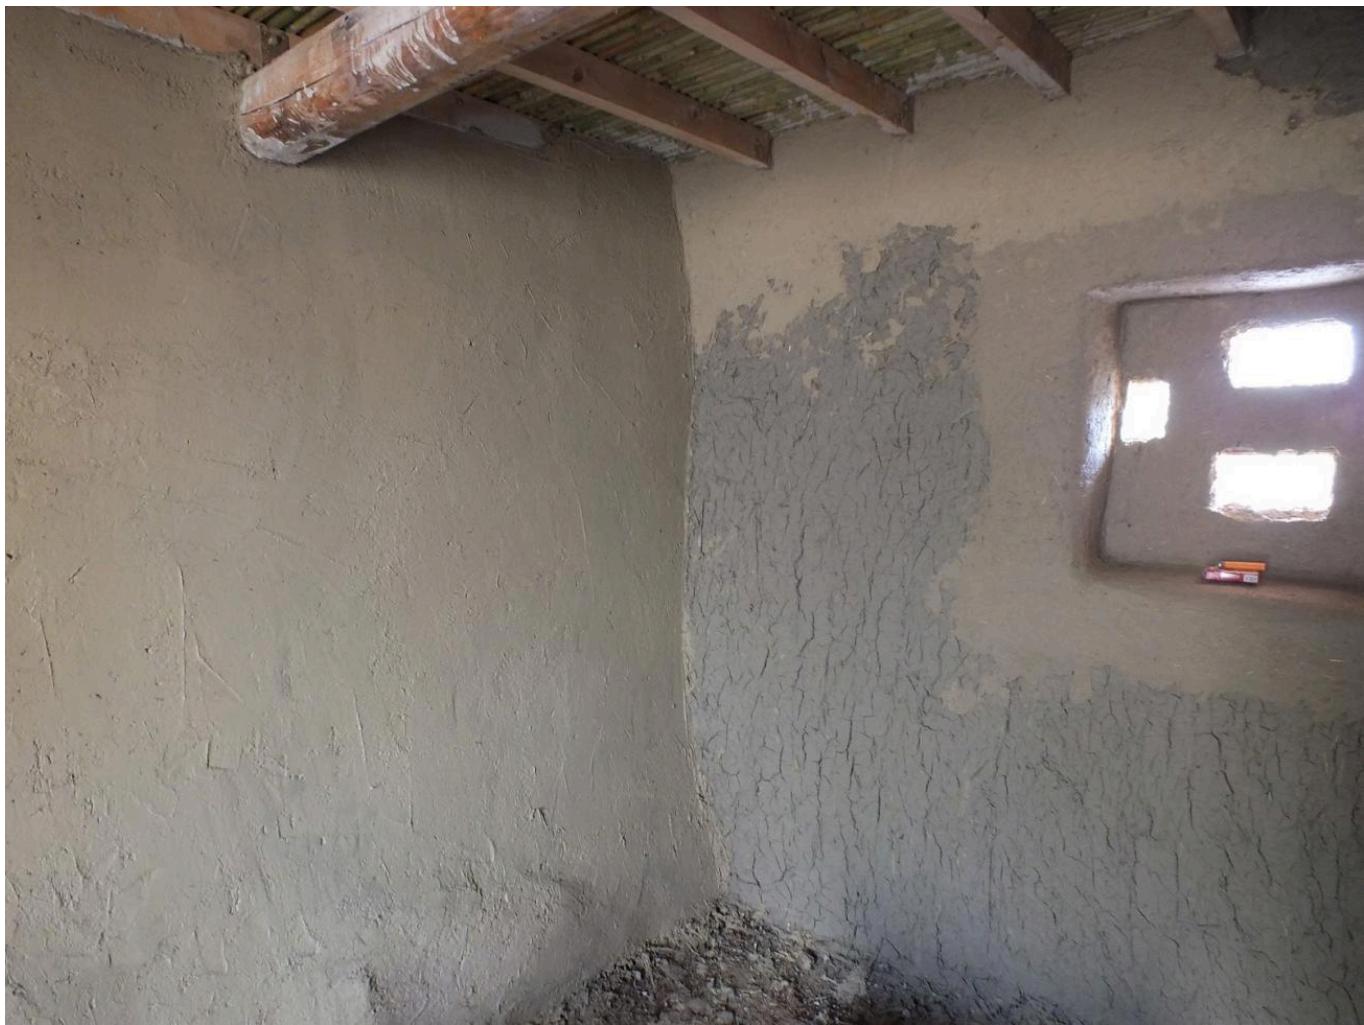
FIG 24. ROUGHCAST AND FINAL RENDERING OF THE PLASTER.

When the roof was nearly finished, with the last layers applied parallel to working on the plaster, the roughcast was applied. It was based on a similar mixture as the bricks, although instead of straw we used chaff to prevent the surface from becoming too rough. When that had dried, the final rendering was applied, again containing chaff, but in the finest grade available, with some added lime to give it a harder surface. The cracks in the roughcast were welcome in this case as they provided a better hold for the final rendering (See Figure 24). Both the interior and exterior of the house were treated in the same way.

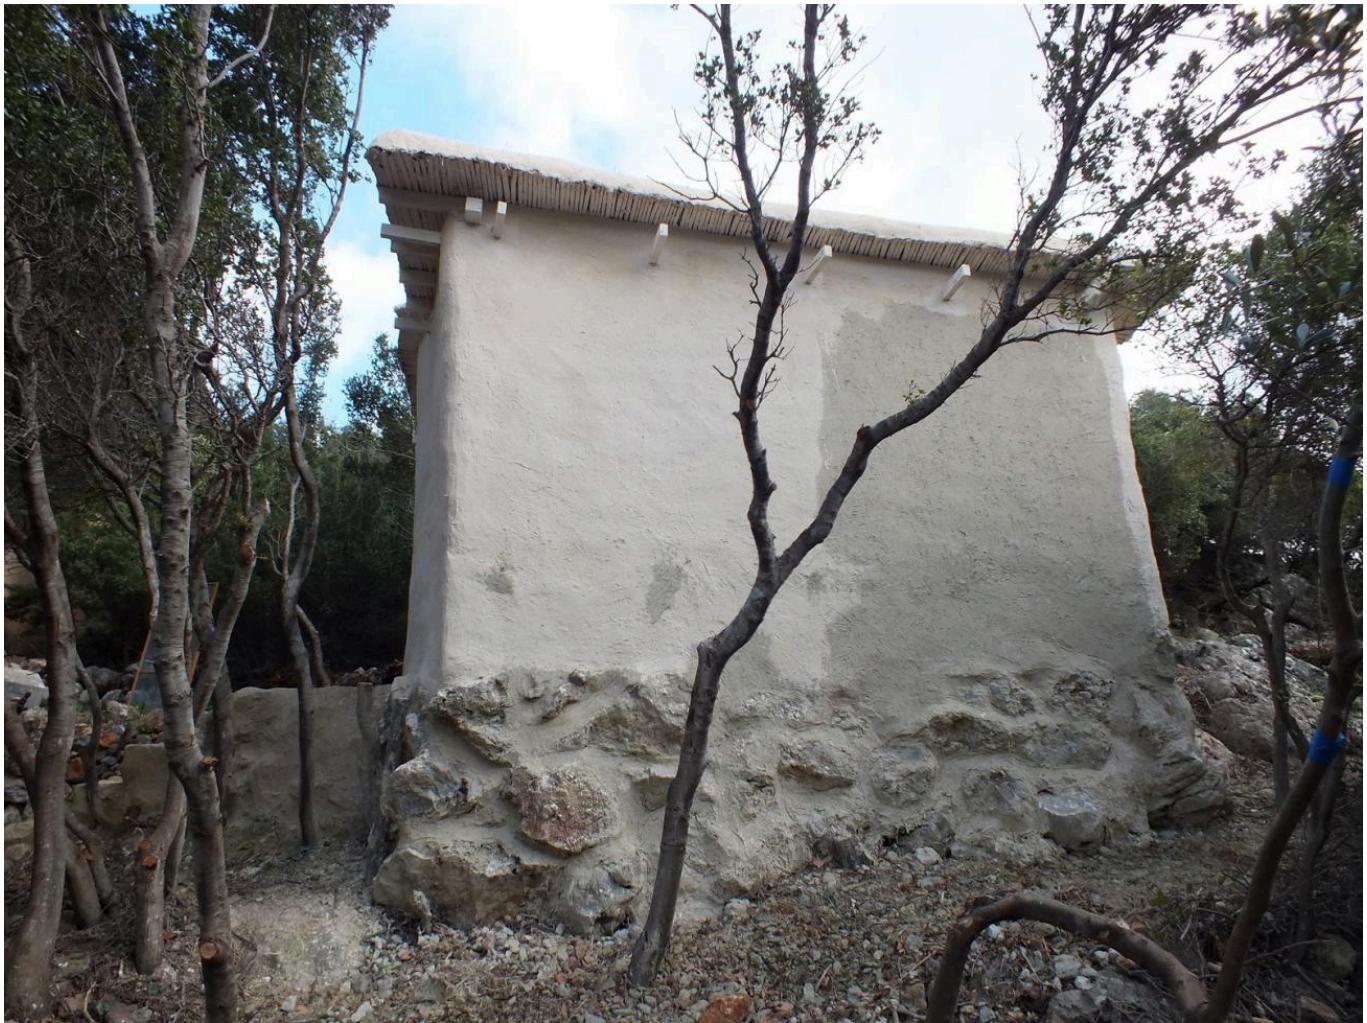
FIG 25. THE WEATHER SIDE WALL AFTER FINISHING IN FALL 2014.

The chaff provided us with an extra smile as after about 10 days, the seeds remaining in the fine straw started to sprout and covered the walls in a thin green cereal field (visible in Figure 27). Finally, we painted several walls with a traditional (also present in the Bronze Age) mixture of lime and mud, the latter mainly for the colour, but also for extra protection from humidity (See Figure 25).

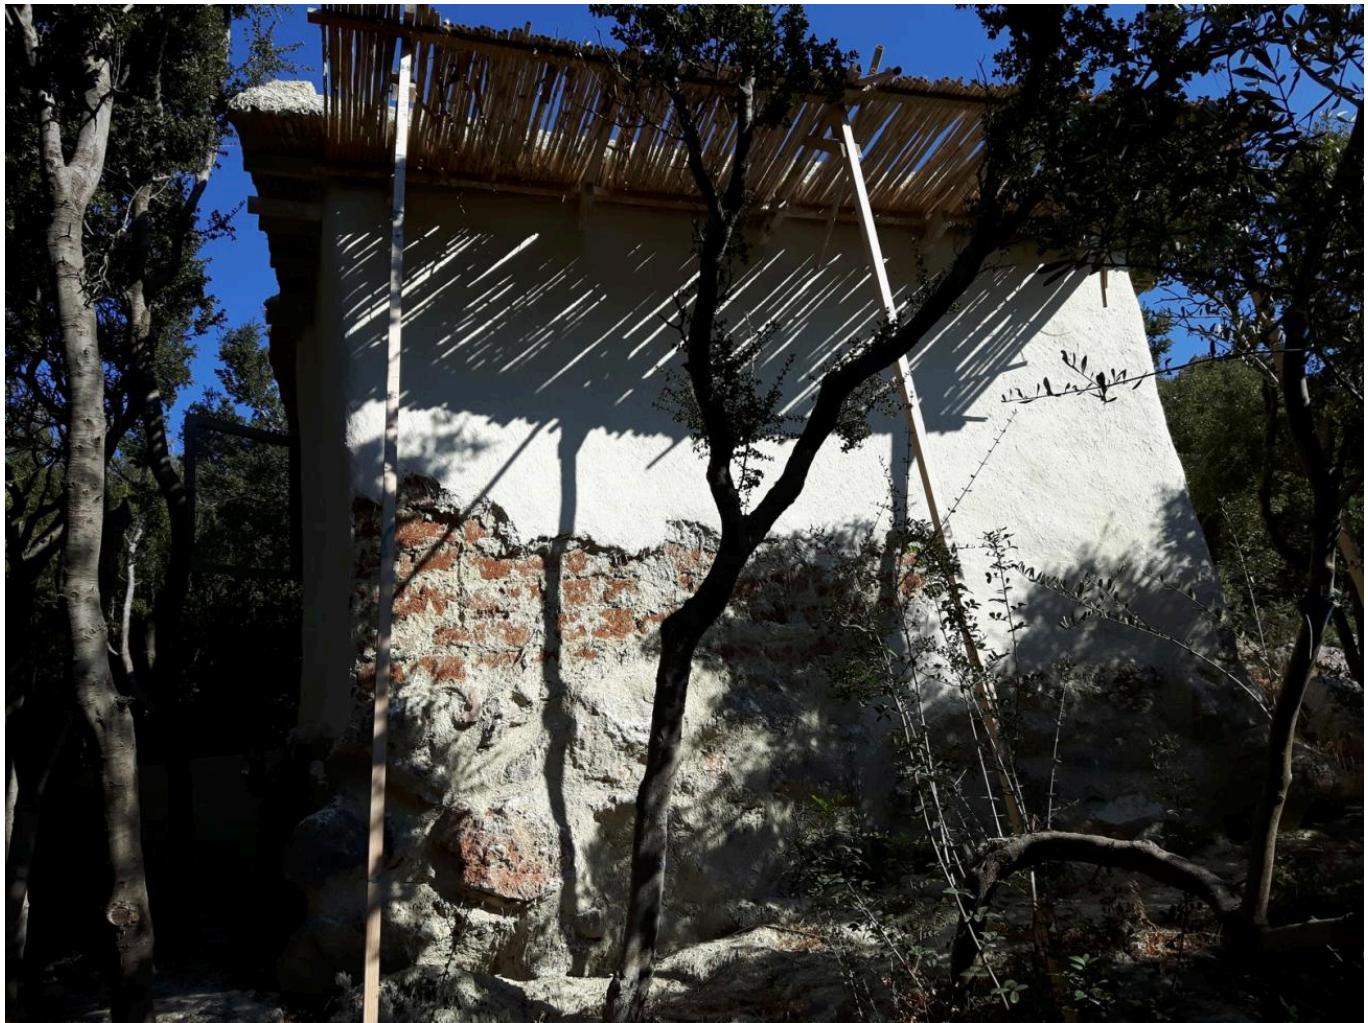
FIG 26. THE WEATHER SIDE WALL SINCE THE DAMAGE IN JANUARY 2015 WITH THE GIANT CANE RAFTERS PROTECTING THE WALL FROM FURTHER HARM.

The most dramatic destruction caused by weather conditions came in January, after the first snow, when heavy, driving rain and hail hit the still slightly moist surface of the western side and a whole slab of plaster – roughcast and all – fell off the wall. The originally pristine lime-painted surface was pocked with small holes from the hail just as the unpainted other half of the wall. This was the point where we decided to put to use the extra small beams which we had inserted into the top of the walls for just such an occasion, as I had theorised that some kind of perishable rafters would have been applied in the Bronze Age - not only for protection of the walls from the weather but also for the benefit of the inhabitants who could sit and work outside in the shade. Our rafters were constructed from giant cane and have functioned perfectly since then (See Figure 26).

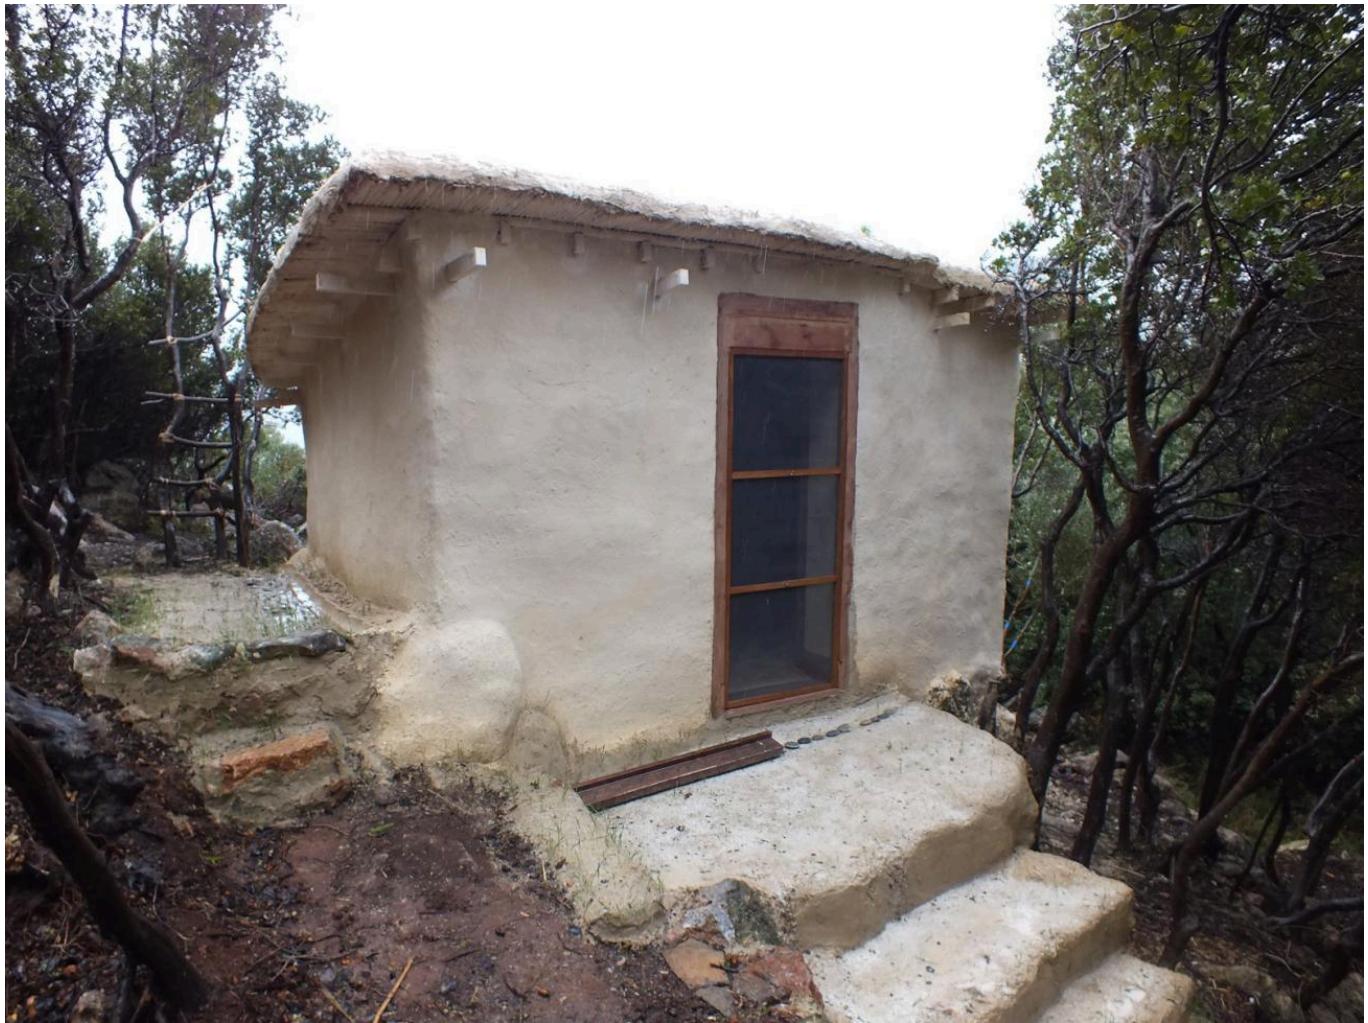
FIG 27. THE EXPERIMENTAL HOUSE JUST FINISHED WITH ITS TREE LADDER TO GET ON THE ROOF, THE DRAIN, THE PEBBLES UNDER THE DRIPPING RAFTERS AND THE PRELIMINARY DOOR, 12/2014. ON VARIOUS SURFACES CEREALS CAN BE SEEN SPROUTING FROM THE CLAY-CHAFF MIXTURE.
