A Minoan Experimental House – Paying Tribute to Middle Bronze Age Cretan Vernacular Architecture

EXARC Journal Issue 2016/4 | **Publication Date:** 2016-12-01

Author(s): Sabine Beckmann ¹

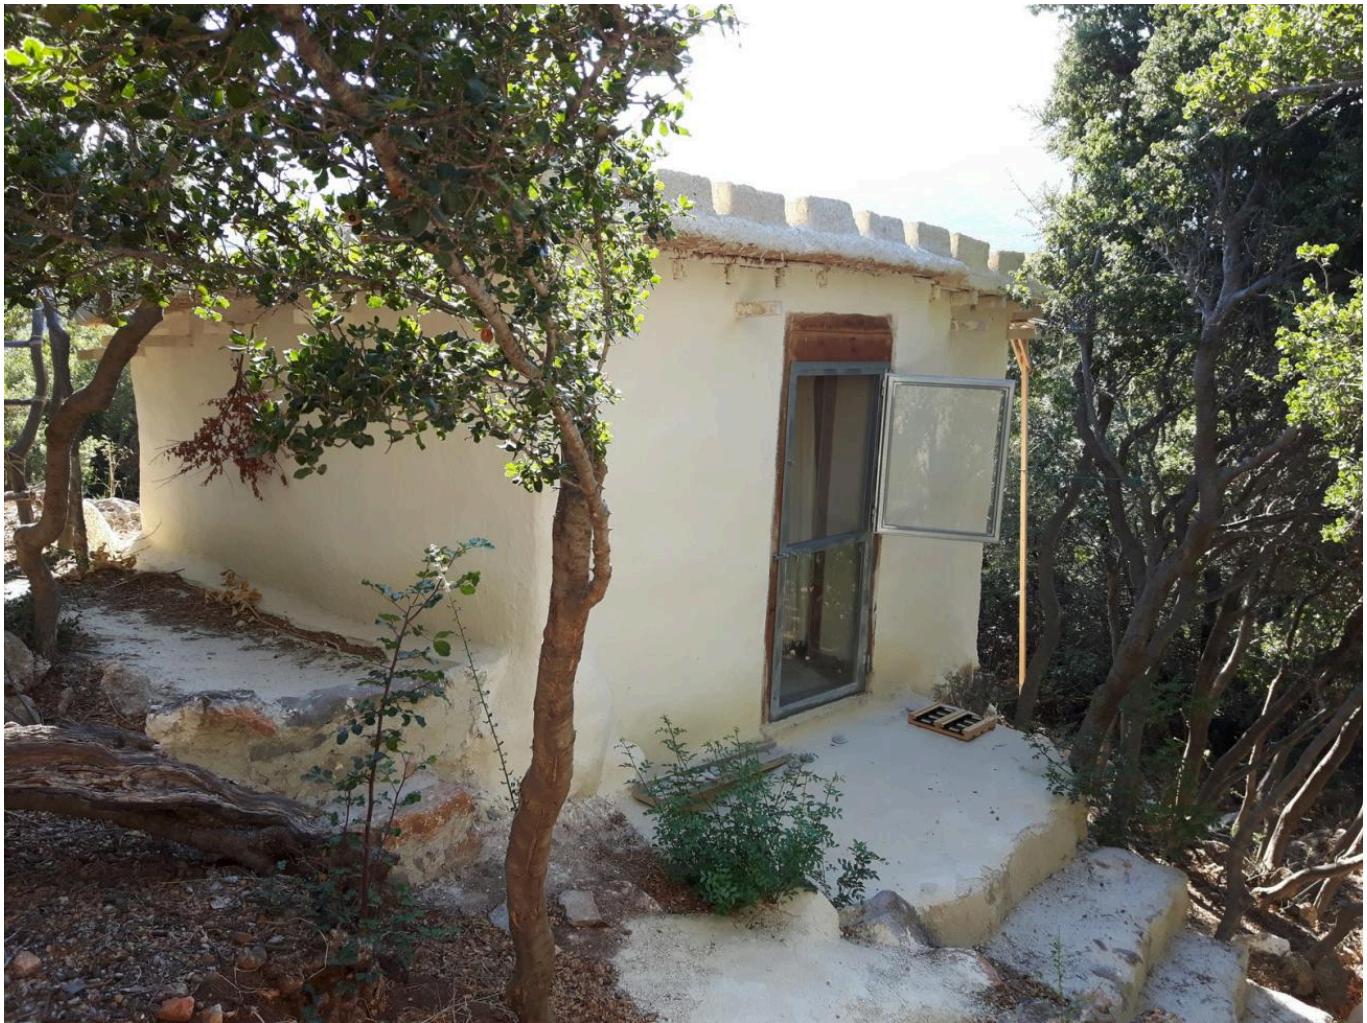
FIG 28. THE HOUSE IN 8/2016, WITH ITS METAL DOOR AND THE "PARAPET" MADE OF SOME REMAINING MUDBRICKS.
