Now we're Cooking with Gas! How Experimental Archaeology Challenges Modern Assumptions about Metal Recycling

EXARC Journal Issue 2017/4 | Publication Date: 2017-11-20

Author(s): E. Giovanna Fregni ¹

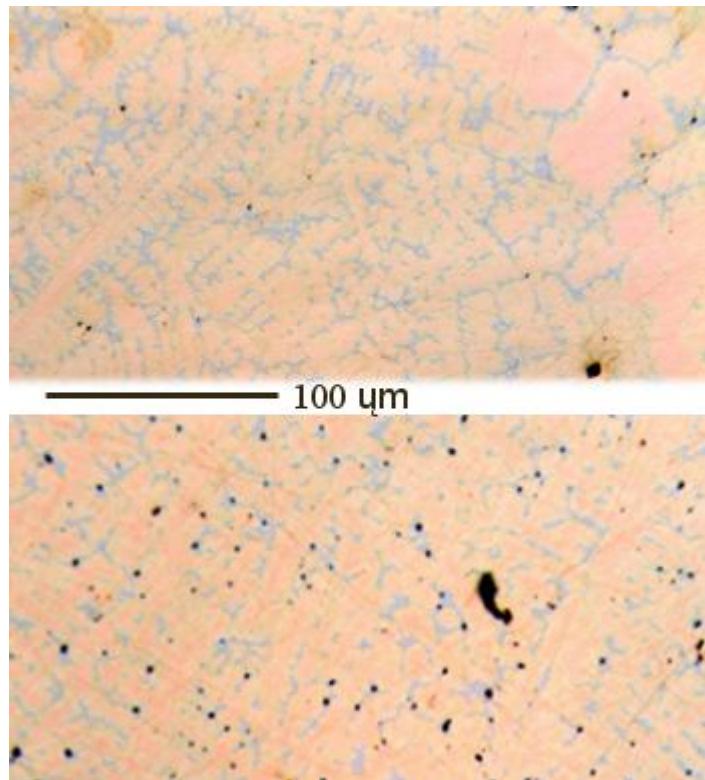
FIG 1. VISUAL EXAMINATION OF SAMPLES FROM THE FIRST EXPERIMENT. THE UPPER PHOTO IS THE SURFACE OF THE UNRECYCLED METAL AND THE LOWER PHOTO IS THE SURFACE OF THE METAL AFTER EIGHT EPISODES OF RECYCLING. NOTE THAT THERE IS NO SUBSTANTIAL CHANGE IN THE METAL OTHER THAN THE SIZE OF THE DENDRITES AND THAT THERE IS NO EVIDENCE OF TIN OXIDATION.

The samples were taken to the metals and glass lab of the University of Sheffield where they were analysed using a Niton portable XRF analyser. It was found that over the course of eight melt cycles there was no detectable loss of tin (See Table 1. Note that the initial reading in each table shows the metal before recycling). Polished samples of the metal were then mounted and examined. The microstructural analysis found no evidence for tin oxide crystals or the presence of a copper-copper oxide eutectic. Well-developed dendrites were visible in all the samples under magnification, with the only variations being the size of the dendrites, which is indicative of the different cooling times of the individual pours (See Figure 1). These results are in contrast to modern foundry practice using electric or gas furnaces where oxidation occurs in concentrations on the surface of the alloy (Cottrell, 1975; Sohn and Sridhar, 2005).

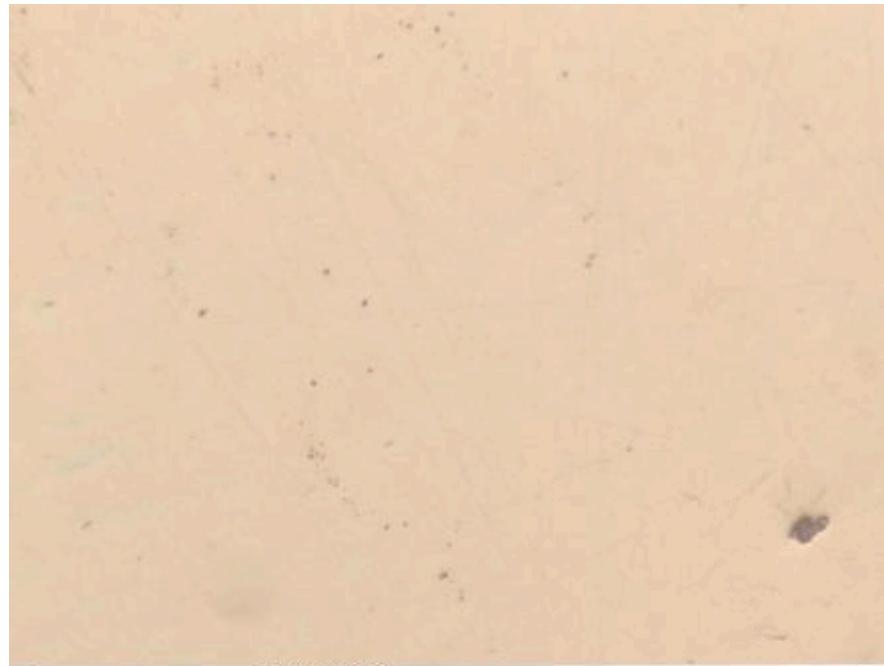
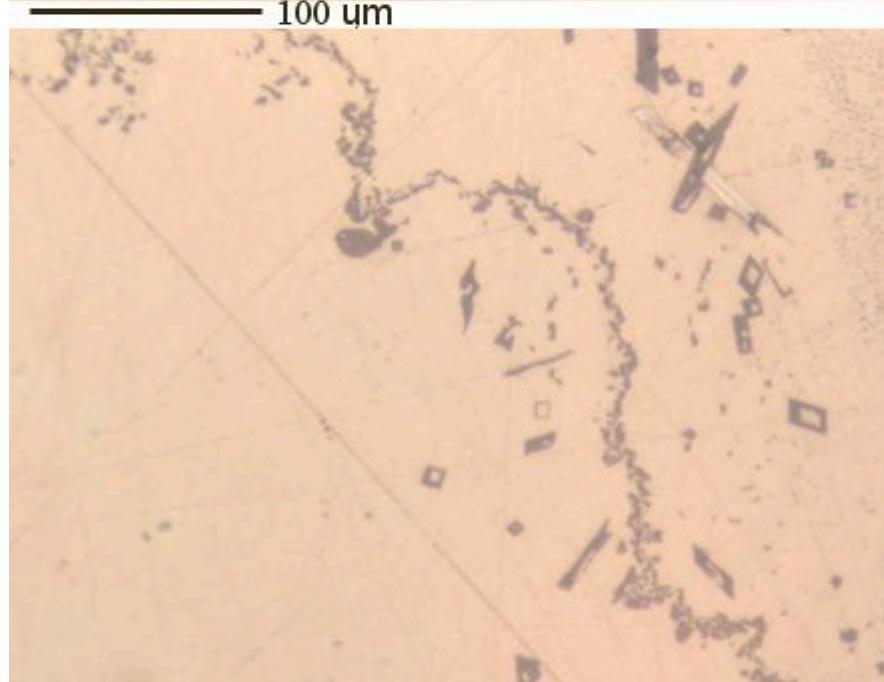
FIG 2. VISUAL EXAMINATION OF THE SAMPLE FROM THE EXPERIMENT USING AN ELECTRIC FURNACE. THE UPPER PHOTO IS THE SURFACE OF THE UNRECYCLED METAL AND THE LOWER PHOTO IS OF THE SURFACE OF THE METAL AFTER BEING HELD MOLTEN FOR TWO HOURS. NOTE THE RECTANGULAR CRYSTALS OF TIN OXIDES THAT HAVE FORMED BOTH INDIVIDUALLY AND IN CLUSTERS.

The samples from this experiment were again analysed using the NITON pXRF, and polished samples were mounted for visual examination. It was seen that the percentages of tin were much reduced. At the end of the first melt, the amount of tin had lowered to an average of 4%. The sample from the final melt lost another 1% of tin (See Table 6). However, because pXRF technology does not distinguish between different forms of metal (e.g. metal and metal oxides) the actual percentages of tin were estimated to be lower, since these could be concentrations tin oxide rather than the primary metal. It was observed that there was a higher concentration of tin on the portion of the sample that was originally the surface of the metal. In the visual examination of the polished sample it was seen that tin oxide crystals were found in small clusters and in a band on one side of the sample (See Figure 2). This

agreed with the pXRF reading showing the spatial variation of tin concentration. The dross and slag were also examined and it was found that the slag was rich in both copper and tin oxides. In the dross sample, distinct separation bands of tin oxide can be seen without magnification and appear as fine cracks and borders on the polished surface, while the individual crystals of tin oxide that form the separation bands can be seen in detail under magnification (See Figure 3).

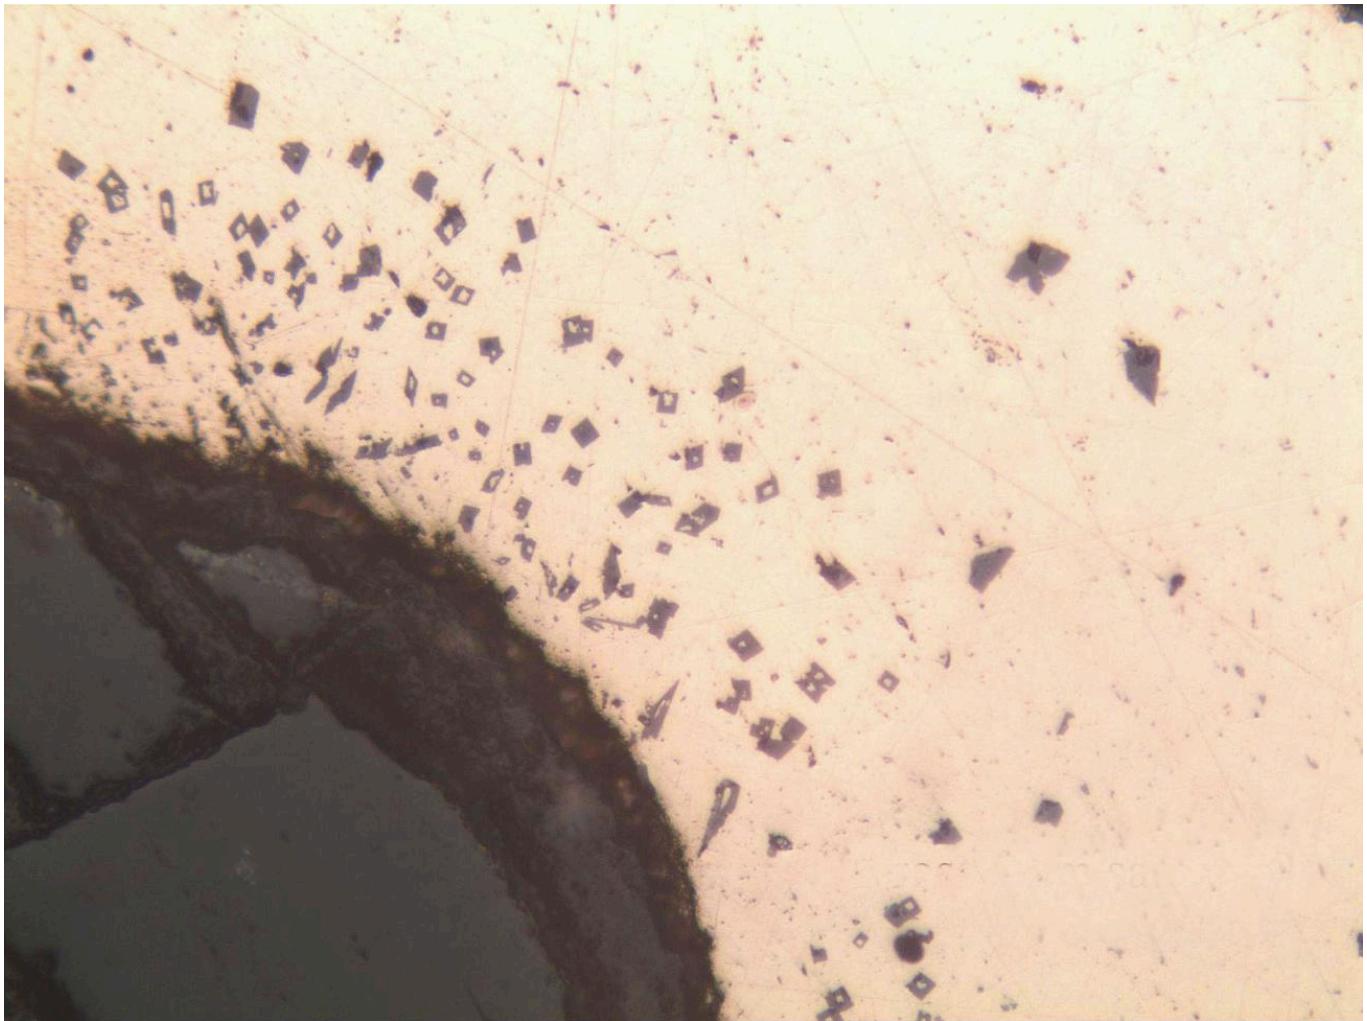
FIG 3. VISUAL EXAMINATION OF THE DROSS THAT FORMED ON THE SURFACE OF THE ALLOY AFTER MELTING IN AN ELECTRIC FURNACE. CRYSTALS OF TIN OXIDE ACCUMULATED NEAR THE SURFACE OF THE DROSS SAMPLE. DISTINCT SEPARATION BANDS OF TIN OXIDE APPEAR AS FINE CRACKS AND THE INDIVIDUAL CRYSTALS OF TIN OXIDE THAT FORM THE SEPARATION BANDS CAN BE SEEN IN DETAIL. THESE BANDS ARE INDICATIVE OF THE BRITTLENESS CAUSED BY CONCENTRATIONS OF TIN OXIDE.

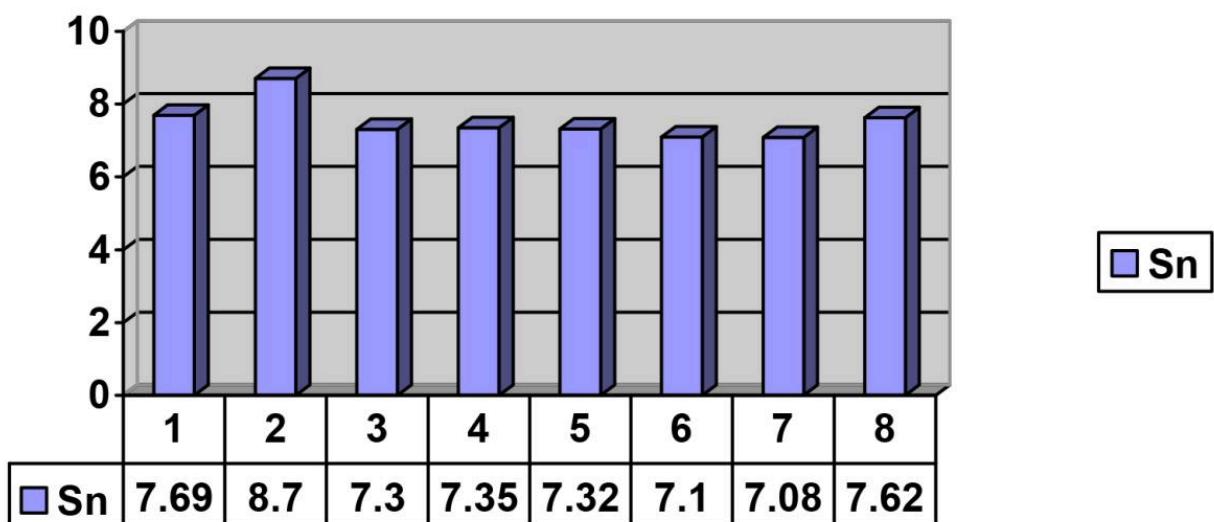
Sn levels in first recycling experiment

TABLE 1. PERCENTAGE OF TIN IN FIRST MELTING EXPERIMENT

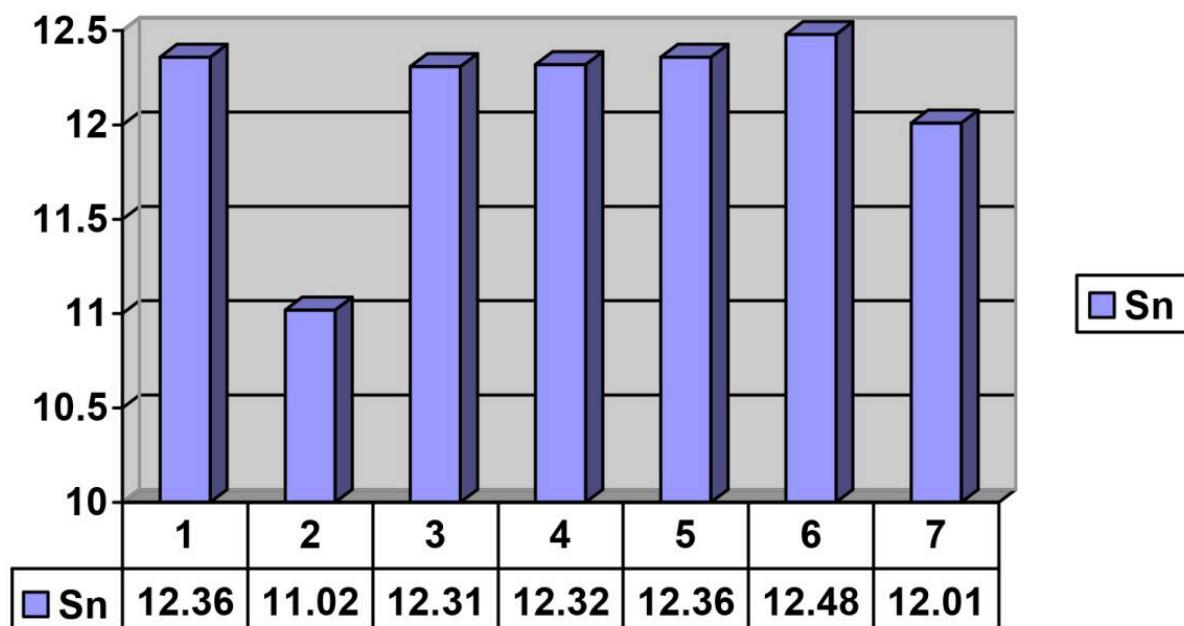
Sn levels in second recycling experiment

TABLE 2. PERCENTAGE OF TIN IN THE SECOND MELTING EXPERIMENT

It was considered that the atmosphere in the furnace could have been reduced because the charcoal was heaped over the crucible, and may have affected the results. For the second recycling experiment a 12% tin bronze was melted with the crucible positioned on top of the charcoal and the bellows positioned to blow air directly at the charcoal, thus allowing as much oxygen as possible to reach the metal. Again the metal was melted, sampled, and re-melted for a total of eight recycling episodes. The results were nearly identical to the first experiment with no evidence of tin loss (See Table 2). The dip in the percentage of tin in the second sample accounted for when analysis demonstrated the homogeneity of the final sample, which shows a difference of as much as 1.16% variation within the sample (See Table 3).

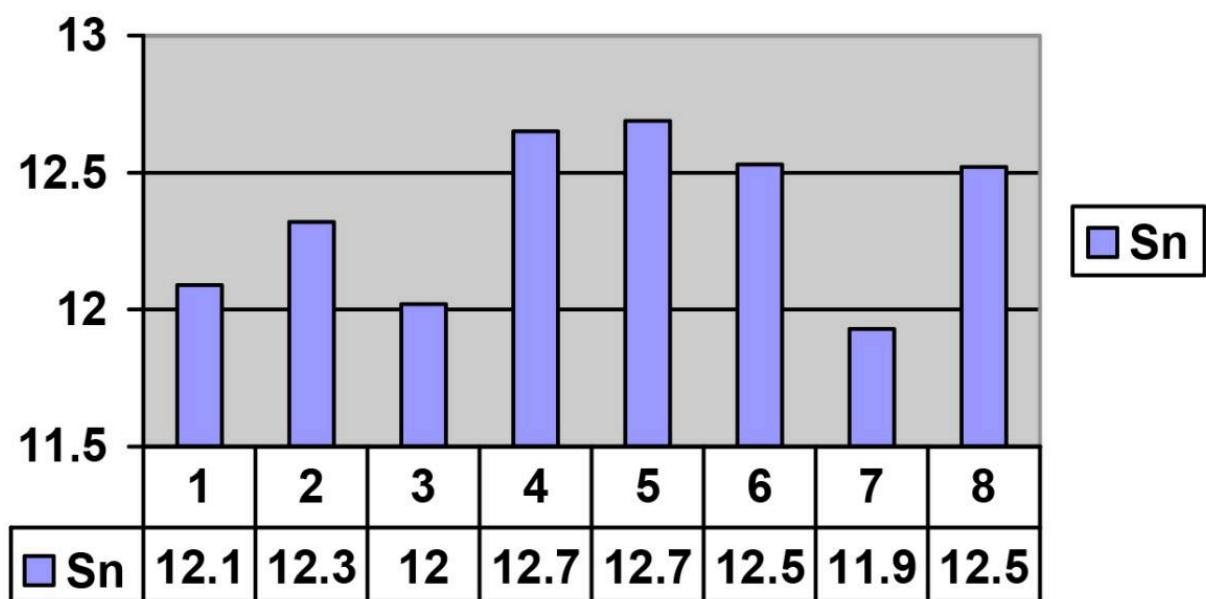
Test for heterogeneity

TABLE 3. TESTS DONE FOR HETEROGENETITY WITHIN THE SAMPLES FROM THE SECOND EXPERIMENT

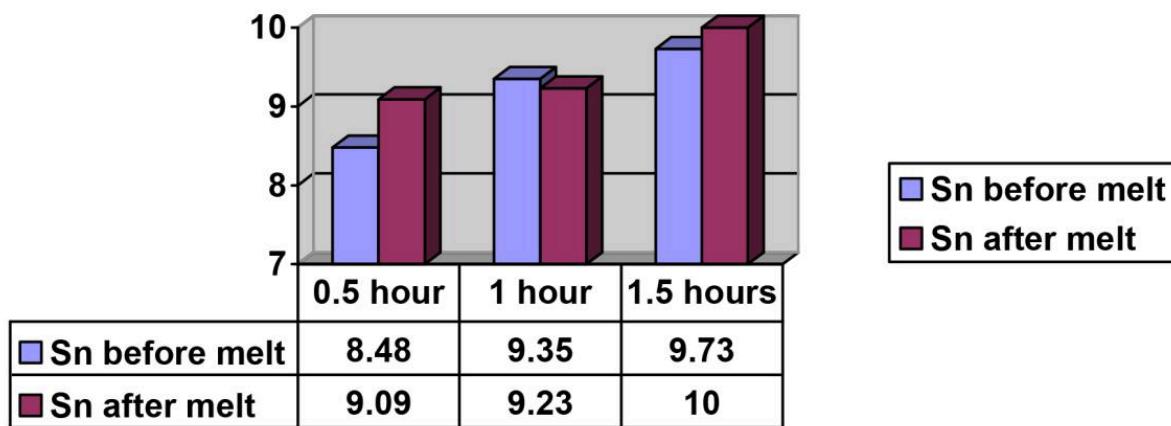
Sn Averages before and after melting

TABLE 4. PERCENTAGES OF TIN IN THE THIRD EXPERIMENT

The preliminary conclusion was that there might have been minimal tin loss in a small number of recycling events, and that changes in the alloy might have occurred if recycling took place on a much larger scale. For the third recycling experiment, it was decided to hold three separate batches of bronze in a molten state for prolonged periods of time. A bar of 10% bronze was cut into three sections and placed in separate crucibles. These were then held in a molten state, the first for one-half hour, the second for one hour, and the third piece for one and a half hours. This was done in order to simulate the melting times for several castings. It was estimated that the average time that it took to pour the bronze and return the remainder to the furnace was fifteen seconds, and if the metal would be held in a molten state for one hour, the result could represent over two hundred recycling events. Despite these extended dwell-times at high temperatures in an open hearth, appreciable tin loss

could still not be detected (See Table 4). It should be noted that in all of the experiments no dross formed on the surface of the metal and there was no slag remaining in the crucible.

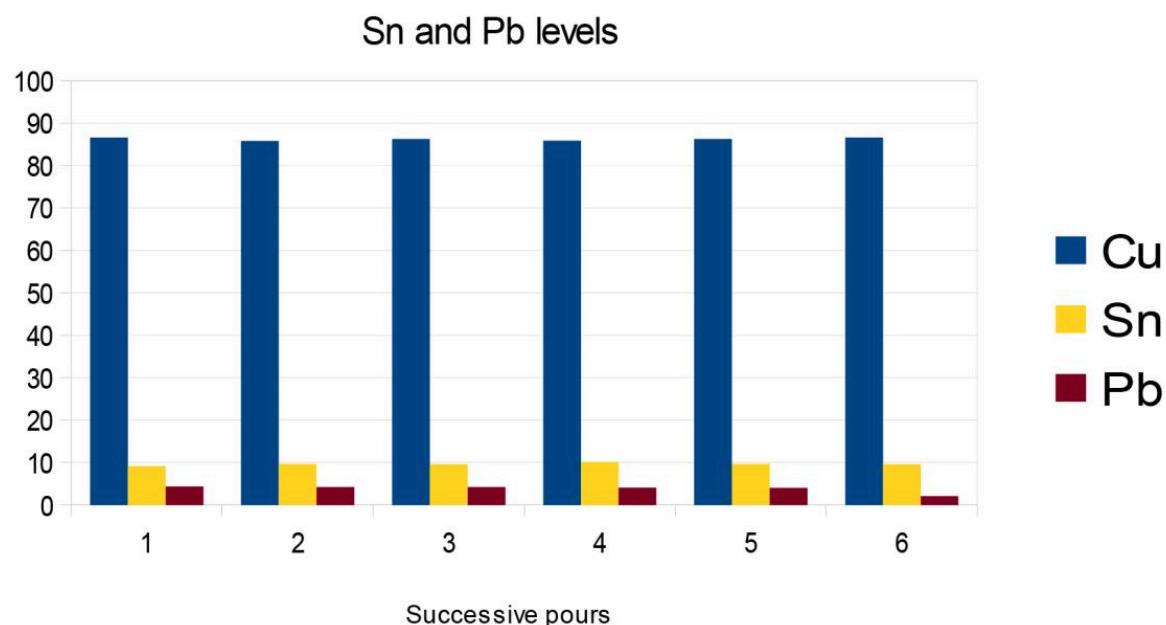
TABLE 5. PERCENTAGES OF TIN AND LEAD IN THE SECOND SERIES OF RECYCLING EXPERIMENTS

The first set of recycling experiments was replicated using a charcoal furnace and bellows, this time using a 90% copper and 10% tin alloy that was purposely mixed for the experiment. A Bruker portable XRF was used for the analyses at the Cambridge University archaeological laboratories, operated by Dr Unavane. The results were substantially the same as in the earlier experiments and no tin was lost during recycling. In addition, the small amount of lead that was part of the alloy was also stable through the recycling episodes (See Table 5).

If no tin is lost when bronze is recycled using a charcoal furnace, then it could also be possible that tin would not be lost if tin and copper were placed in the same crucible and melted together. In the experiment in which the alloy was purposefully mixed (See Table 5), the copper and tin were placed in the crucible and melted at the same time. As can be seen from the data in Table 5, there was no loss of tin, as would be expected using a modern electric or gas furnace.

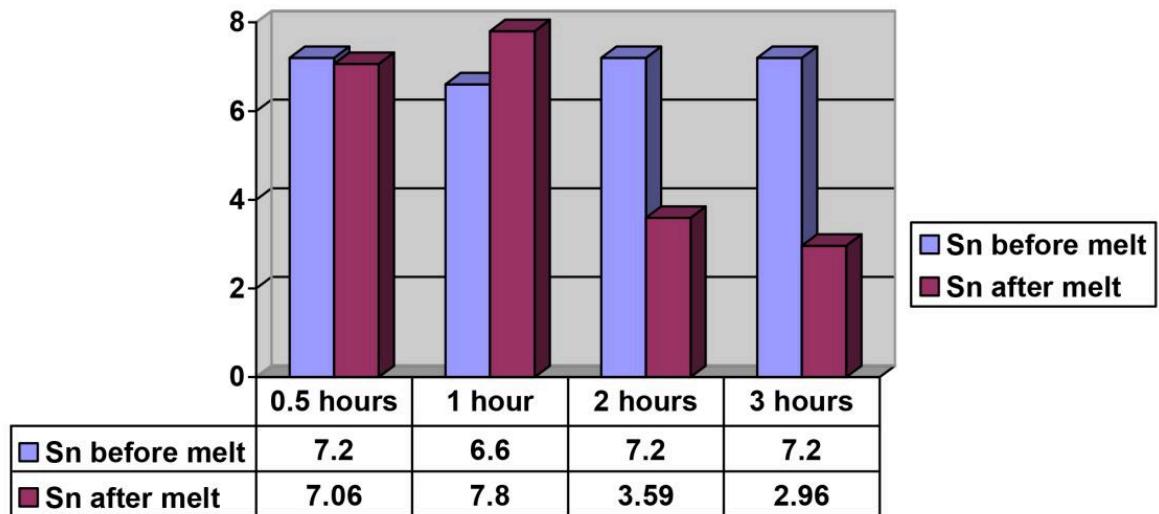
TABLE 6. PERCENTAGES OF TIN WHEN MELTED IN AN ELECTRIC FURNACE
